STUDY THE DETERIORATION OF GRANITE STATUES, KEMAN FARES EXCAVATIONS, FAYOUM, EGYPT

The Main Temple of The Keman Fares built in the beginning of Middle kingdom. Different Granite statues are excavated in this site.

The analytical study of the deterioration of the granite statues are made by using different analytical techniques such as thin section and scanning electron microscope.

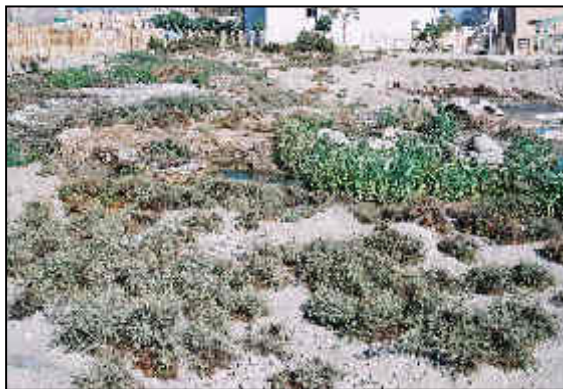
Fig. 1: General View of keman shows the raising of groundwater and urbanization effect on the granite statues.

Groundwater raises in this site **Figs. 1,10** assists in the weathering of granite statues and the weathering of feldspars, plagioclase and biotite.

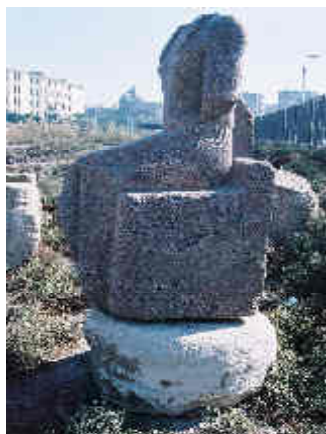
Fig. 2: Exfoliation of granite statues.

The main weathering forms in the Keman fares are granular disintegration, plates, scales, flakes, exfoliation, efflorescence and Microbiology colonization **Figs. 2, 9**. The soluble salts are also responsible for granular disintegration. The high intensity of granular disintegration is associated with a high concentration of salts. The most common salts occurring in efflorescence are Sulphates, chlorides, nitrates and magnesium chloride. Salts are extremely dangerous, because they are very soluble, hygroscopic and redissolved. They are very mobile and thus they penetrate and break up many crystalline structure.

Granular disintegration (**Fig. 3**) is responsible to the loss of granite material. The statues show the loss of hardness and polish leading to minerals alteration. The textural anisotropy of the granite leads to the grow of cracks while progress its physical deterioration giving rise to planes of weakness. The degradation of granite materials decays tends to be by exfoliating (**Figs. 2,3**). Also weathering and kaolonization of granite statues observed in **Fig. 4**.

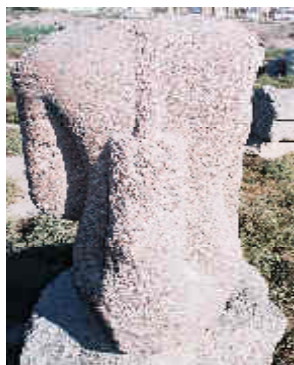
Fig. 3: The exfoliations and the granular disintegration of the granite statues.

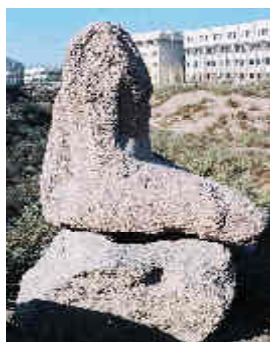
Fig. 4: The weathering and kaolinization of granite statues .

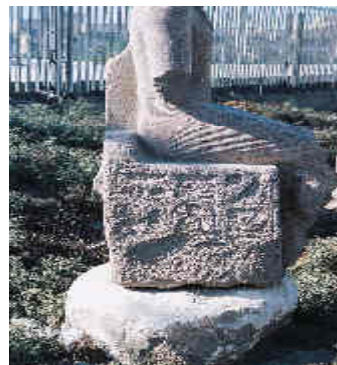
Also Biocolonization is present (**Fig. 5**) moreover, plant roots commonly grow in the fractures of granite stones and impacts the Amenhotep III statues (**Figs. 1, 5**). Destruction of grainte statues are shower in **Fig. 6**.

Fig. 5: Biocolonization, plant roots grow in the fractures of granite statues.

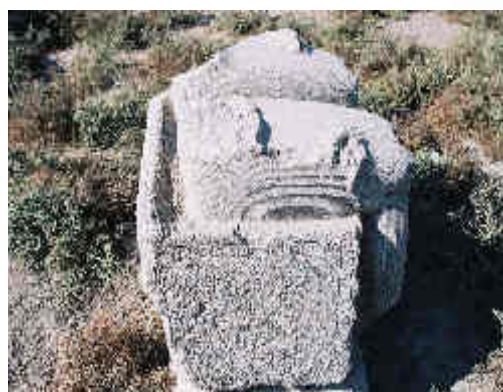
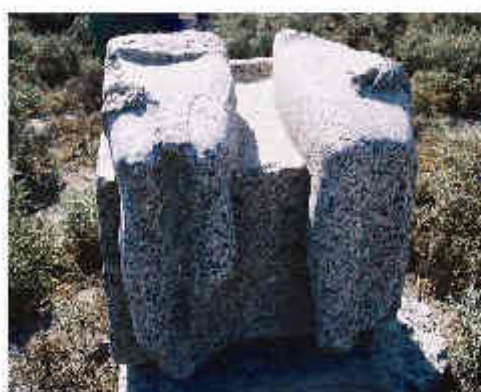
Fig. 6A: The destruction of granite statues.

Fig. 6B: The destruction of granite statues.

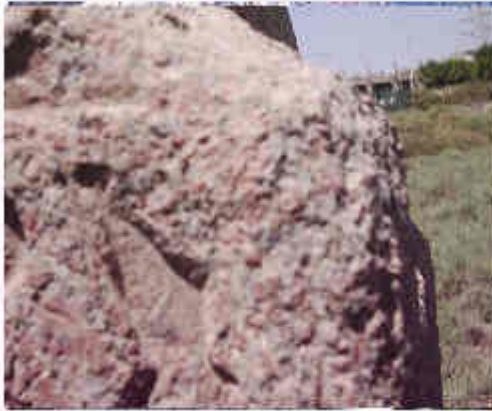
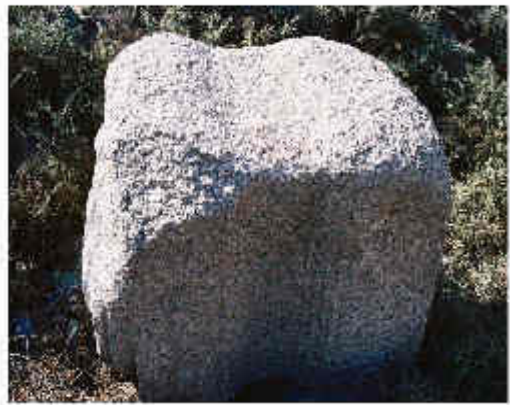
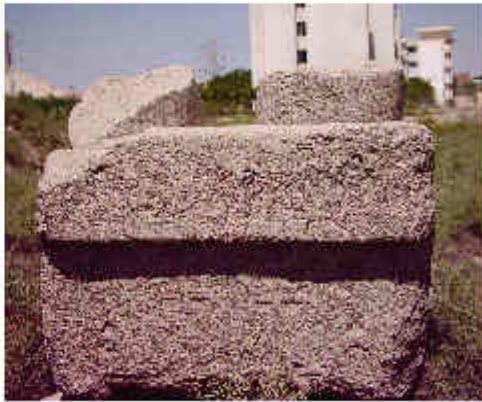
Scaling of Fayoum granite statues where the sheets separate from the stone blocks parallel with the outer surface due to the disintegration of grains and separation of these grains with separation of scales of surface layer (**Figs. 7, 8**). Two types of

Fig. 7A: Granular disintegration is grain by grain disaggregation .

Fig. 7B: Granular disintegration is grain by grain disaggregation.

Fig. 7C: Granular disintegration is grain by grain disaggregation.

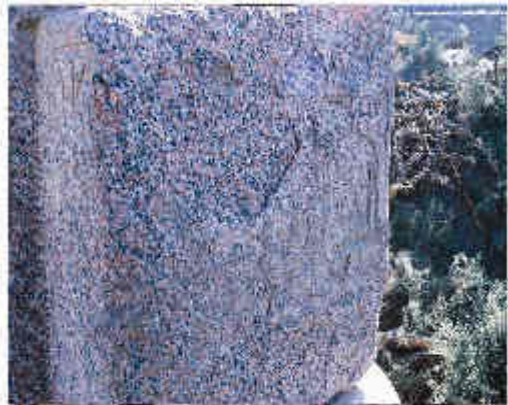
Fig. 8: Scaling is observed on granites.

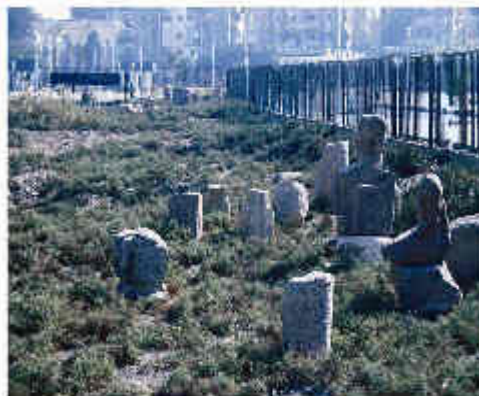
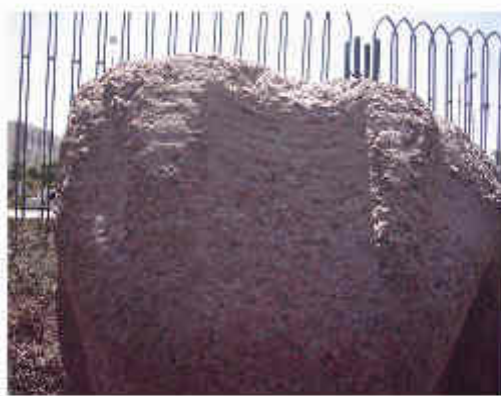
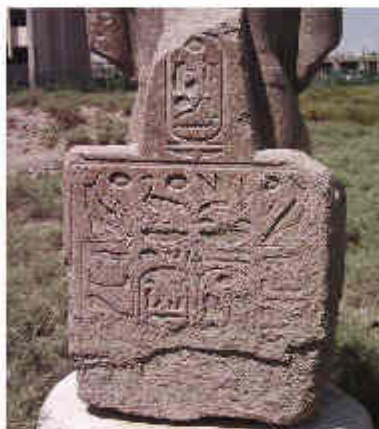
The vegetation and Microbiological colonization in Keman Fares plays a significant role of weathering which directly absorbing significant substantial mafic minerals (**Fig. 9**) [13, 14].

Fig. 9A: The vegetation in keman fares plays a significant role of weathering.

Fig. 9B: Loss of details in granite statues.

Fig. 9C: Shows scaling and exfoliation of granite statues.

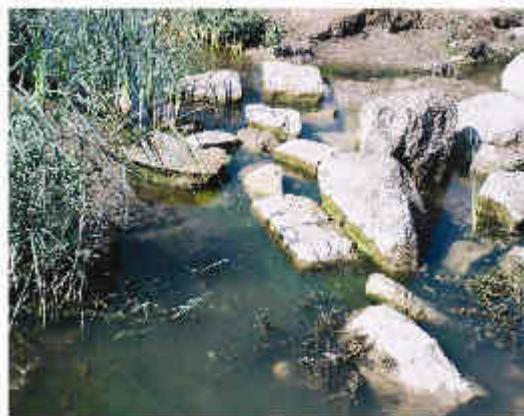
Fig. 10: The vegetation and colonization and raising of groundwater in keman faris site.

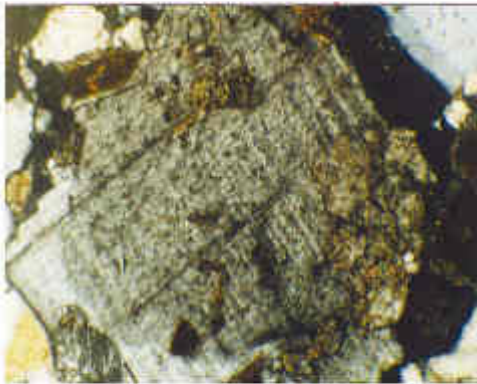
Orthoclase is highly divided into numerous residual dominions by a network of subparallel transverse cracks combined with some irregular longitudinal cracks (**Fig. 11**). Plagioclase alters and is impregnated with iron rich compounds. The internal border of the rim is highly irregular and the products of weathering irregularly penetrate the residual core along digitating and branching fissures. A transmineral fractures cut a feldspar grains by following one cleavage direction of the mineral (**Fig. 12**). These fractures are formed by later transition of the feldspar fragments. A long transmineral fracture cuts grains of quartz and weathered feldspars in the granite stone. The highly hydrated material has an intermediate chemical composition between that of the original feldspar and that of kaolinite. The material is slightly stained by iron oxides, a blood red to black pigmentation as a thin layer or crust (**Fig. 12**).

Fig. 11: Shows the alteration of plagioclase to sericite and kaolinite and gypsum. Parts of crystals are slightly altered .

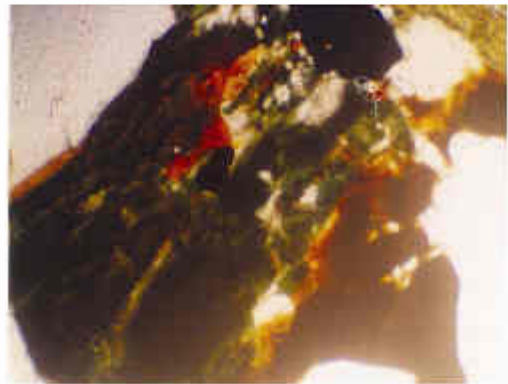
Fig. 12: Shows the alteration of biotite and plagioclase to iron oxyhydroxides (red colour) and chlorite (green colour).

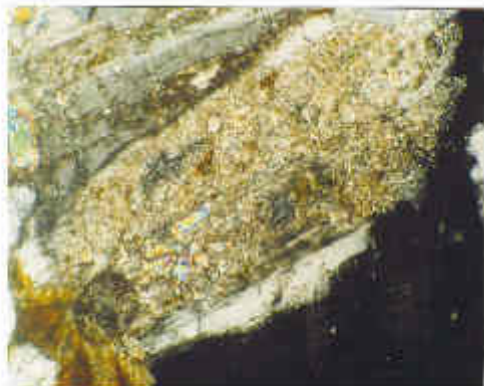
divided by a crossing network of linear fissures (**Fig. 13**), which follow the two intersecting cleavages of the mineral. Plagioclase is largely replaced by very fine particles of sericite appearing pale grey in (**Fig. 13**) The transformation of plagioclase to sericite and kaolinite is shown in (**Fig. 14**).

Fig. 13: Plagioclase is largely replaced by fine particles of sericite .

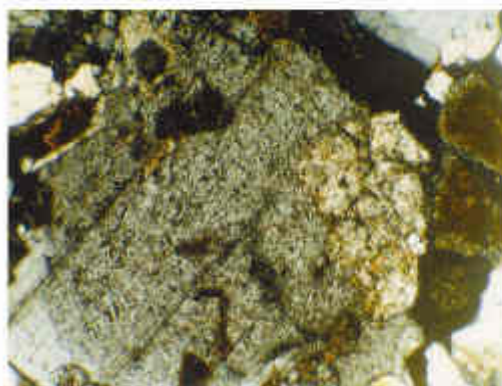
Fig. 14: Shows the alteration of feldspars to kaolinite and sericite.

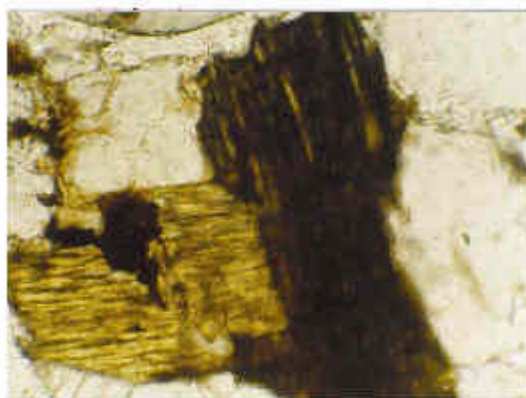
The stone contains an appreciable amount of Hornblende and biotite, both minerals exhibit good cleavage, which allow the easy development of fractures and the isolation of the less breakable components (**Fig. 15**).

Fig. 15: The deformation of quartz and biotite. The cracks are filled by secondary material.

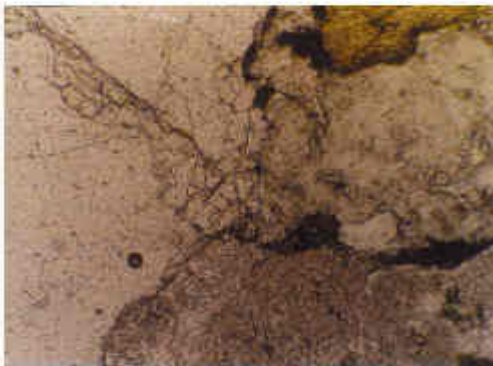
Biotite crystals are replaced by Kaolinite and carbonaceous manila. This replacement is accompanied by a substantial increase in volume result in the opening of many trans/and intermineral fractures (**Fig. 16**). This network of fractures provides the pathway for the absolute accumulation of material derived and crystallized from percolating solutions. The flakes of biotite are weathered to a smectite. The replacement generally starts along the periphery of the flakes and extends irregularly toward the center of the mineral. The weathered biotite seems to be the main source of

Fig. 16: Shows different cracks filled by carbeneous material and the deformation of quartz .

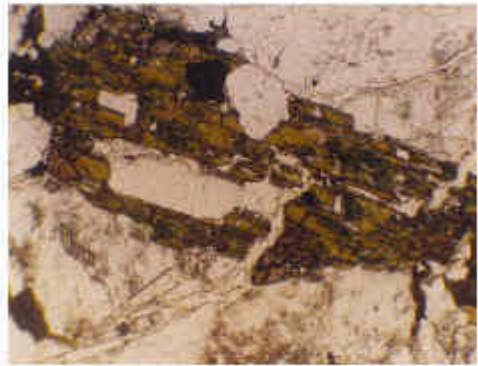
the clay material of the transmineral in fillings. Also patches of gypsum as a result of alteration of are observed from deterioration (**Fig. 17**).

The transformation of biotite to Kaolinite and iron oxyhydroxides and is the most important weathering features (**Fig. 17**).

Fig. 17: The deformation and alteration of biotite to chlorite in particular through

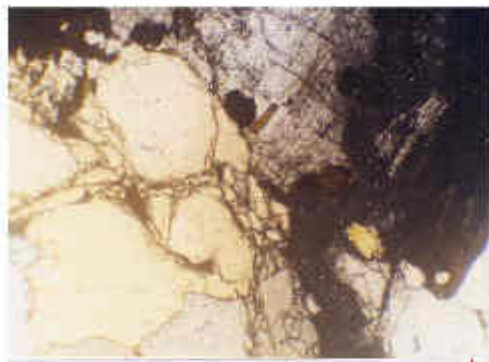
Fig. 18: Deformation of stone and the cracks are filled by carbonaceous material.

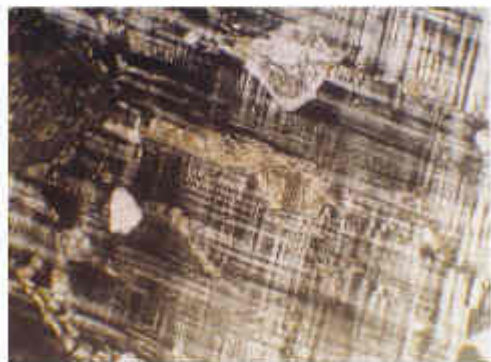
Fig. 19: The alteration of microcline to sericite and kaolinite .

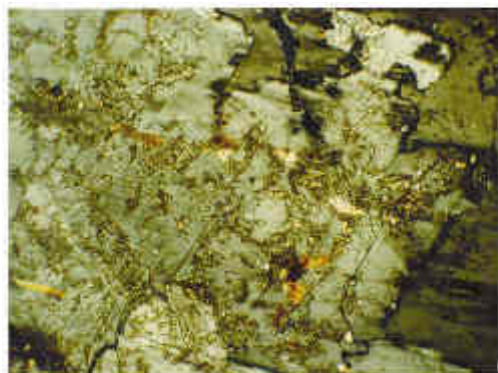
The biotite has weathered to semecite. The buildup of pressure due to the swelling of the clay promoted the deformation of all the partially developed materials after biotitte into small elliptical clays. The deformation of biotite is expressed by irregular alignments of elliptical domains, which may have developed from a single crystal of biotite. The infilling material within the neighboring open fractures and pores are shown in (**Fig. 18**).). The red-colored layers of iron oxyhydroxides are regularly associated with lenticular or planar intramineral areas irregularly distributed around the pores and within all the extramineral pores associated with infilling of dark-brown ferruginous products (**Fig. 19**), and thick layers of Kaolinite are regularly distributed between more iron- rich layers; lenticular intramineral pores also present. They may be infilled by Kaolinite pigments penetrated into cracks and cleavage planes in the individual mineral grains or coating the grains as this film (**Fig. 20**). This pigmentation

Fig. 20: The kaolinization of orthoclase to kaolinite.

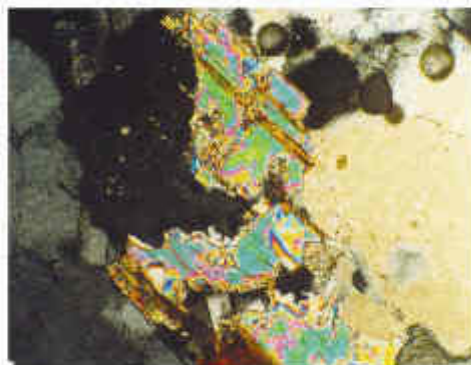
due to the degradation of the iron bearing minerals such as iron oxides (**Fig. 21**). All the fragments of the stone are actually separated from each other. Most of the fractures were initially accordant fractures, despite of the slow internal movements of the components. Some of these fractures are infilled by alteration products and coated by hydroxylated minerals (sericite in feldspars) (**Fig. 21**).

Fig. 21: The alteration of plagioclase to sericite and gypsum formation are due to air pollution .

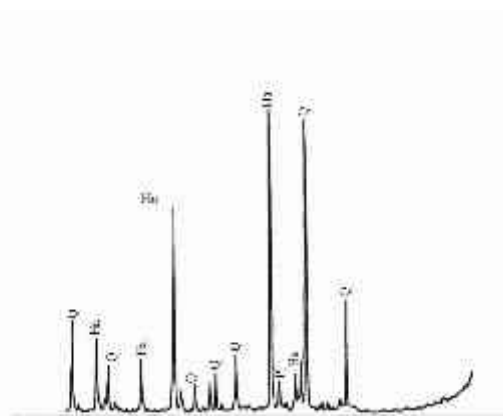
X-ray diffraction chart (**Fig. 22**) revealed the presence of plagioclase, biotite and quartz as major minerals whereas biotite, gypsum are the minor minerals X-ray diffraction (**Fig. 23**) shows the presence of gypsum. Gypsum is assumed to be the cause of the surface layer detachment. In the deterioration of statues, gypsum sericite, Kaolinite and chlorite are the results of weathering.

Fig. 22: X- Ray diffraction shows the presence of major and minor minerals.

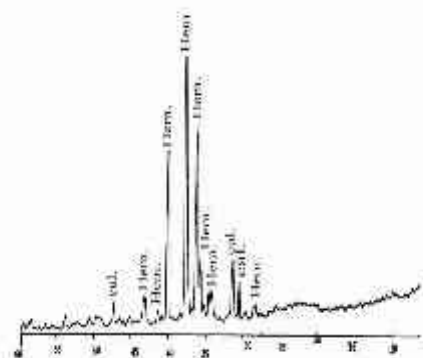
Fig. 23: X- Ray diffraction shows the presence of gypsum

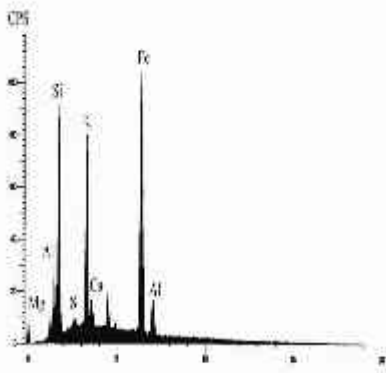
EDX reveals the higher concentration of iron, silicon and potassium (**Figs. 24, 25**) shows the increase of calcium and sulphure due to gypsum.

Fig. 24: EDAX shows high iron, silicon and Potassium concentration .

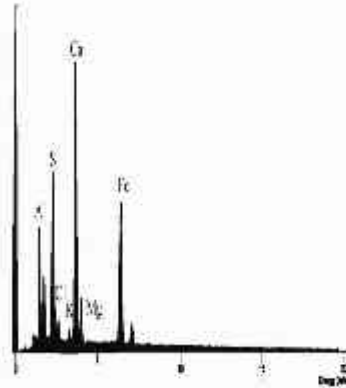
Fig. 25: EDAX Patten shows the elemental concentration of keman fares granite.

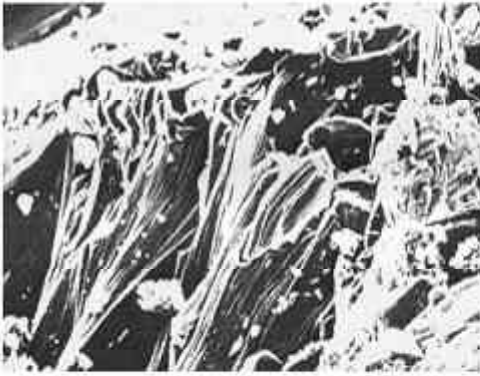
SEM micrographs revealed different microcracks inside the mineral constituents, **Fig. 26**. Microcracks show long, narrow sharp ended cracks. SEM analysis shows microfractures and microcracks inside the mineral grains with the dissolution cavities **Fig. 27**. **Figure 28** shows the strong deformation and transformation of feldspars to clay minerals. SEM micrographs shows the presence of halite and gypsum crystals within the cavities and microfractures **Fig. 29**. SEM shows the pigmentation of the mineral grains and interspaces between the grain boundaries.

Fig. 26: SEM shows different microcracks with narrow sharp ended cracks.

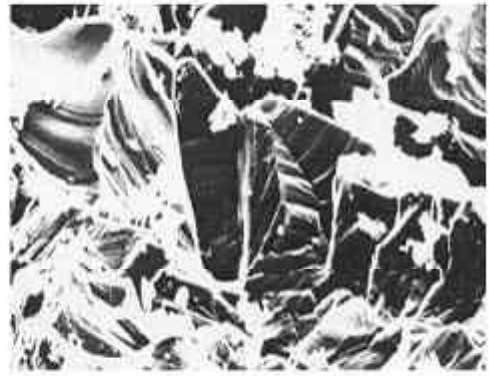
Fig. 27: SEM shows microfractures within mineral grains with dissolution cavities.

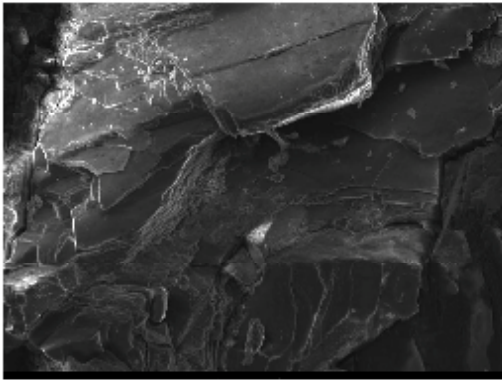
Fig. 28: The strong deformation and transformation of feldspars to clay minerals.

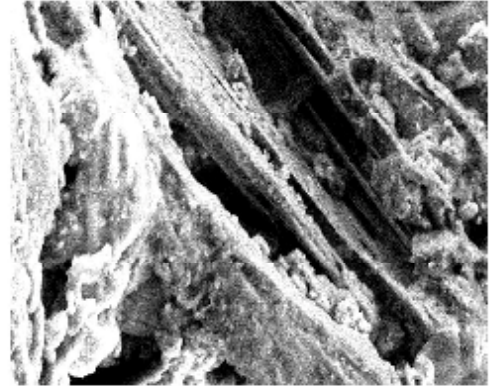
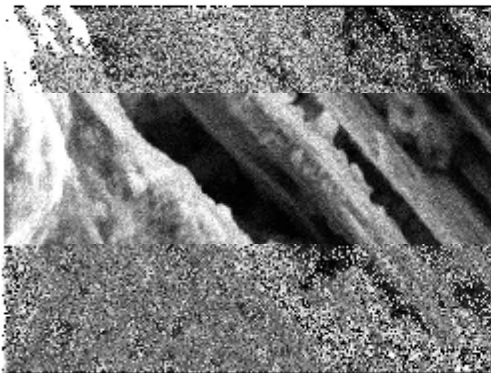
Fig. 29A: The presence of Halite and gypsum within the cavities and microfractures .

Fig. 29B: The presence of Halite and gypsum within the cavities and microfractures .

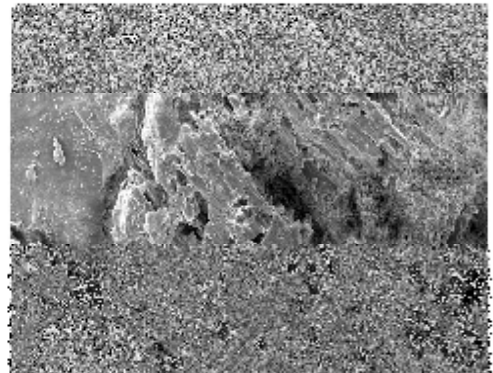
Pitting or alveolar weathering are present due to the activity of microorganism inside feldspars and biotite **Fig. 30**. SEM shows the efflorescence and the crystallization of salts in cavities and microcracks. SEM (**Fig. 31**) shows the transformation of feldspars into clay minerals along fissures and microfractures. Gypsum occurs as acicular crystals distributed in the cavities inside the stone. SEM reveals the high content of salts.

Fig. 30: The pitting and alveolar weathering due to the activity of microorganism .

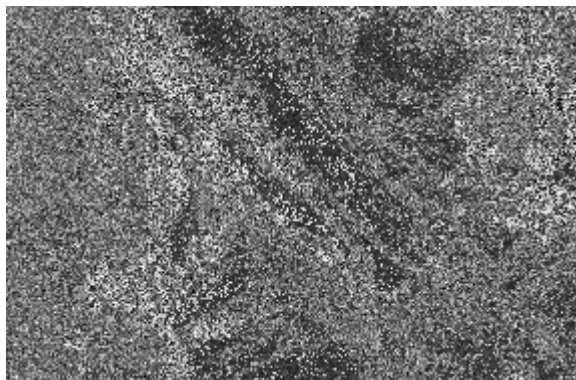
Fig. 31: The transformation of feldspars to clay minerals along fissures and microfractures .
