## SEISMIC EVALUATION OF CRACKED MASONRY BARRAGE PIERS REPAIRED WITH DIFFERENT METHODS

AHMED S. HASHAD\*, MOHAMED I. ABUKHASHABA

*Construction Research Institute, Delta Barrages, Egypt*

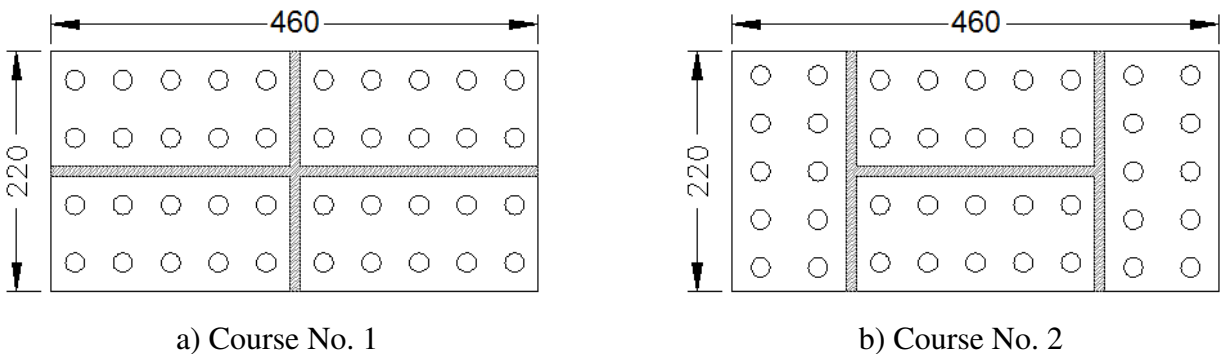
**Fig. 1.** Brick arrangement used in piers construction

In order to investigate the effect of various repair techniques on the seismic structural response of masonry piers, a total of four masonry piers having a dimension of 460mm long, 220mm wide and 1250mm, height were built on the shaking table using commercial traditional clay perforated bricks, that commonly produced in Egypt and used nowadays in most of masonry applications, to model the barrage piers, and tested. For piers constructing process, the bricks were arranged as shown in Fig. 1. Four steel bars of mild steel with 8mm diameter fixed in staggered arrangement reinforcements were used for one of masonry piers, while two tie rods of high grade steel with 10mm diameter were used for applying pre-stressing force of 1 ton for one other pier. All masonry piers were built on a foundation layer consists of plain concrete with 70mm thickness. Fig. 2 shows the tested piers built on the shaking table. Table 1 illustrates the material properties.

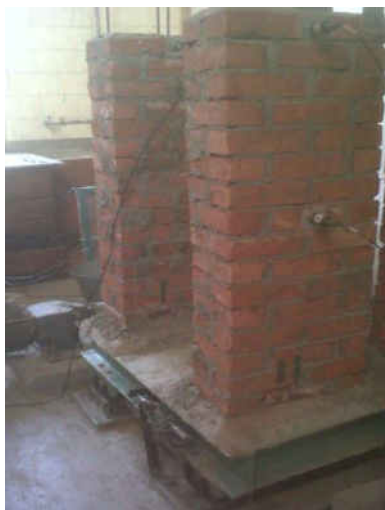
**Fig. 2.** Masonry piers built on shaking table.

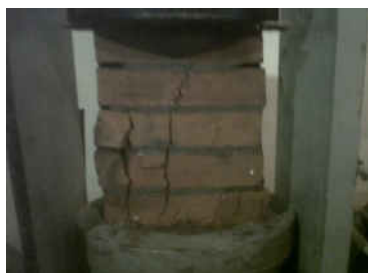
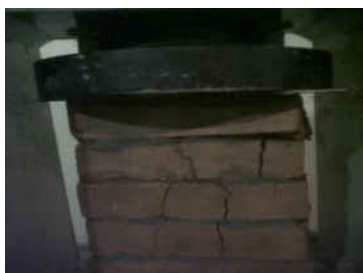
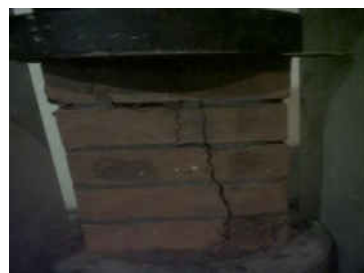
**Fig. 3.** Some tested prism samples under compression test.

All piers were built using ordinary techniques for masonry buildings. The piers were built at the same time with the same brick and mortar type and with the same labors. For quality control purpose, five prisms were prepared based on Egyptian standard [15]. The prisms were built with the same mortar used for constructing the tested piers. They were tested in compression to estimate the average compressive strength of the tested piers. The compressive strength was found in the range of 3.2 to 3.8 N/mm<sup>2</sup> with the average of 3.5 N/mm<sup>2</sup> with acceptable degree of convergence among the tested prisms. This convergence proves that all the tested piers have the same average strength. Fig. 3 shows some of the tested prism specimens after being failed under the compression test.

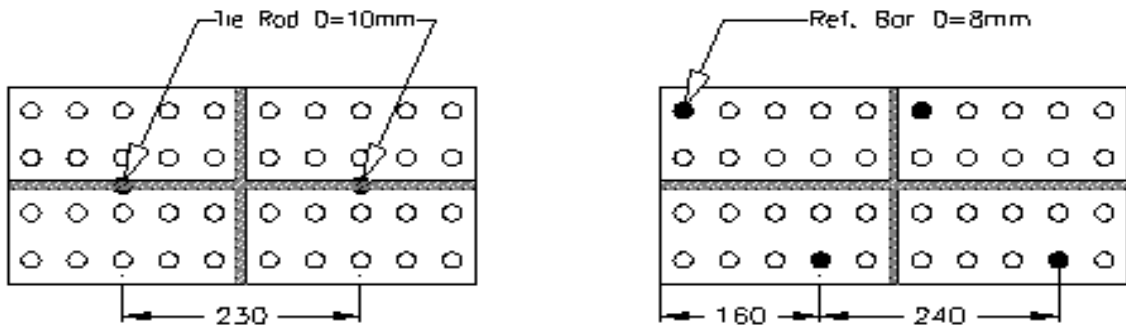
a) Tie Rod Configuration

b) Stapled Bars Configuration

**Fig. 4.** Stapled bars and tied anchors configuration.

One of the fourth piers called pier No. 1 represents the original sound uncracked case and left without strengthening to be a reference for the cracked-repaired cases. For the other three piers, an artificial crack was configured at the same level and almost covered the whole pier cross section. The three cracked piers were repaired by using three different crack repair techniques. One of the three cracked piers called pier No. 2 was repaired by pasted technique using epoxy while in the second pier named pier No. 3; the crack was stapled using reinforced steel bars. For the third pier which called pier No. 4, the crack was repaired by tied with anchored bolts. The configuration of stapled bars and tied anchors are shown in Fig. 4.

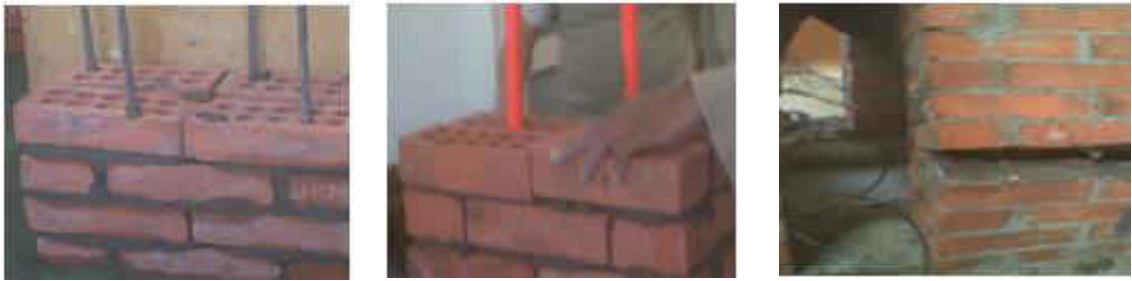
a) Stapled Pier

b) Tied Pier

c) Pasted Pier

**Fig. 5.** Tested models during construction.

For the purpose of experiments simplicity, piers No. 3 and 4 were prepared during construction process. The third pier was stapled by using steel bars to simulate the reinforced masonry walls techniques. The steel bars used were four mild steel bars with 8mm diameter fixed in a staggered arrangement. The steel bars were fixed inside the brick holes as demonstrated in Fig. 4 sketch. Then, these holes were filled with mortar. Figure (5-a) shows the steel bars inside the brick holes. The fourth pier was constructed as the first pier but was provided with two tie rods of high grade steel with 10mm diameter to carry pre-stressing force =1 ton. The tie rods were put in a plastic pipe during the construction of the pier to apply the pre-stressing force after construction completion of the pier and gain its stress resistance. Figure (5-b) shows the tie rods inside plastic pipes. Figure (5-c) displays pier No. 2 in which the epoxy was used to paste the crack.

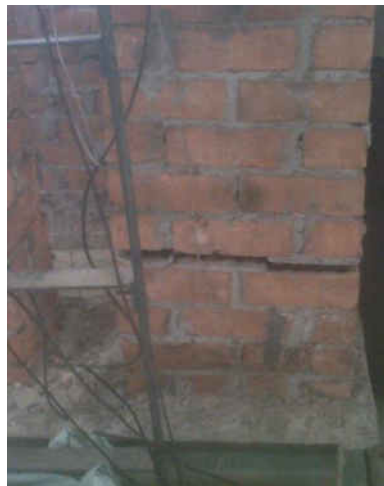
**Fig. 6.** Crack location determination test.

The crack level was determined from previous set of experiments carried out on piers similar to the original one [14]. The pier was subjected to base vibration load. The acceleration of the vibration load was continuously increased until failure occurs. The location of crack causing failure was then determined. Fig. 6 shows the location of crack causing pier failure. This location considered the most critical section and a similar crack was initiated in the other three piers using saw cut technique as shown in Fig. 7.

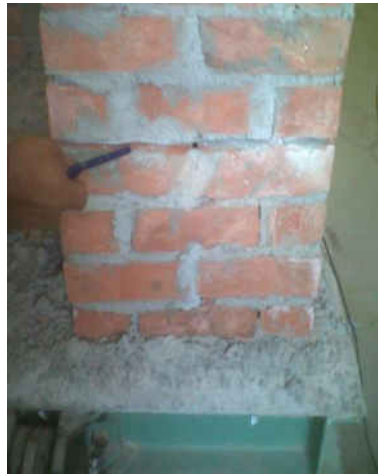
**Fig. 7.** Artificial crack formation.

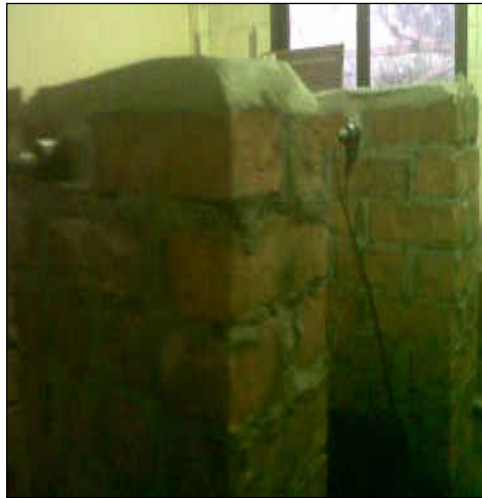
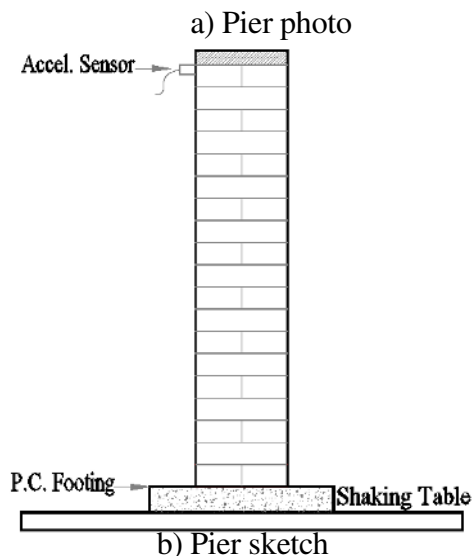
**Fig. 8.** Some instrumentation mounting tested masonry piers.

The responses of the piers were measured using accelerometer sensors. Three accelerometers were used to measure each pier acceleration response. The accelerometers were fixed at the top of each pier where maximum response was expected. Figure 8 displays the instrumentation devices used in the tests and its location on tested piers. The accelerometer sensors send the measured signals to a conditioner unit which in turn sends the conditioned signal to a data acquisition card through connecting cables. The acquisition card passes the digital data to a laptop computer for the purpose of data storage and analysis. The logging software controls the measuring process and converts analog signals to digital ones. The data is filtered and analyzed using the signal processing techniques. These techniques were applied on the measured acceleration- time record. These techniques such as Cut-off frequency technique filter are used to remove noises to get acceptable signal-to-noise ratio. The type of the data acquisition cards is PCD-320A. The software produced by KYOWA is used to control and filter the measurements. The data analysis software used is Mescop. The time lengths of input harmonic excitations were 20 sec. while the sampling rate was 100 sample/sec. A low pass filter with 40 hz cut off frequency was applied to overcome signal noise problems.

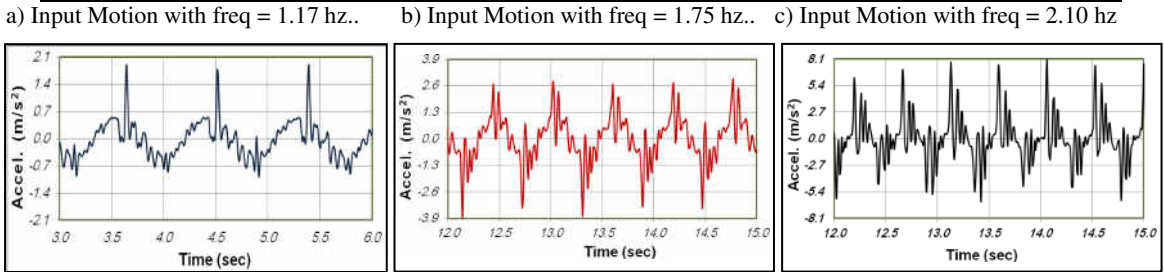
**Fig. 9.** Some input motions applied on the tested piers.

The acceleration responses during shaking the piers were measured. The piers were subjected to three input motions with three different frequencies and with 20.0 sec. time length before applying crack pattern and then repeated after applying crack pattern and repair techniques to compare directly the effect of repair technique on the pier dynamic behavior. The frequencies of

the applied motions were 1.17, 1.75, and 2.10 hz respectively. Figure 9 displays the different input motion. The piers were subjected to other set of input motions with higher frequencies till failure occurs. At input motion with frequency 2.55 hz and peak acceleration  $8.40 \text{ m/sec}^2$ , the original pier was failed then after a few seconds the pasted pier was also failed. The last two piers still resist the base motion load till the tied pier slipped over the shaking table as a one unit. The slipping failure occurs at base motion load with frequency 3.57 hz and peak acceleration  $16.70 \text{ m/sec}^2$ . The stapled pier could stand against base motion with frequency up to 4.28 hz and peak acceleration  $24.00 \text{ m/sec}^2$ .

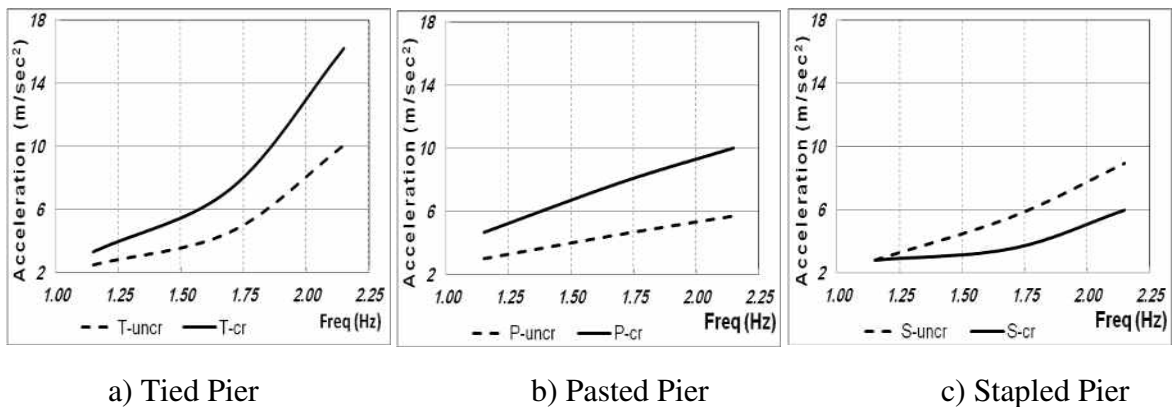
**Fig. 10.** Effect of crack on peak acceleration response for different repair technique.

For each repair technique a comparison between the acceleration response for the uncracked situation and the repaired crack one was done for the same repair technique. Figures (10-a), (10-b) and (10-c) display the pseudo acceleration responses for uncracked and the crack repaired situation for tied pier, pasted pier and stapled pier respectively. Results clarify that both pasted and tied techniques increased the rigidity for the pier while the rigidity for stapled pier was decreased. The results were matched with tests methodology, since the crack was induced firstly and then bonded with a strong material which is responsible for increasing the rigidity in the first case. Moreover, the crack was also induced in the tie-case and then applying the prestressing force, while in the staple-case the crack was induced in the whole section which was reinforced from the beginning and the crack was left as it was and the reinforcing bars were used to provide the staple effect which weakens the section.

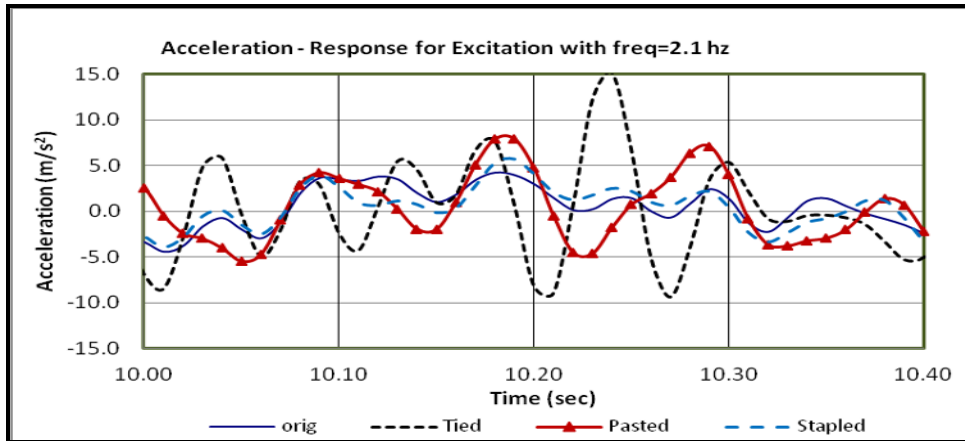
**Fig. 11.** Acceleration responses time wave form for the tested piers.

The acceleration-time responses for the tested piers are displayed in Fig. 11. These responses are examined under the applied input motions with frequency 2.10 Hz and peak ground acceleration  $6.94 \text{ m/sec}^2$ .

The results of the tests showed that the acceleration response of the stapled pier is the most similar to the original pier. Pasted pier has a degree of convergence with the original pier while the acceleration response of tied pier has different trend than other piers.

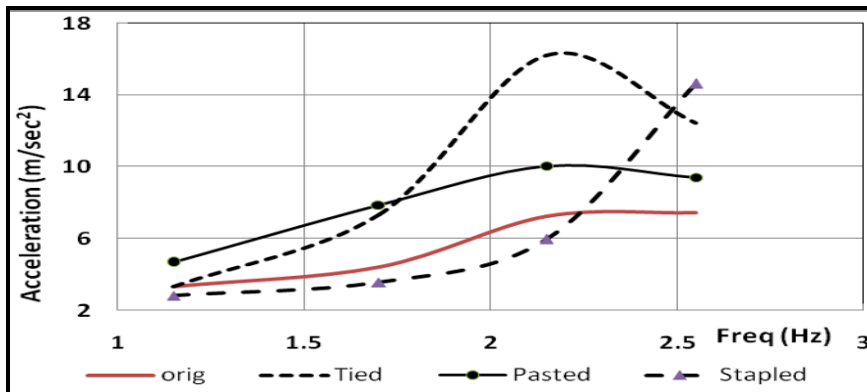
**Fig. 12.** Peak acceleration responses for the tested piers.

This behavior can be clarified by plotting the peak acceleration response against the input motion frequency. Figure 12 displays the relation between the peak acceleration response and input motion frequency for the four piers. For input motion frequency lower than 2.5 hz, a considerable convergence between original pier and stapled pier can be recognized. The pasted pier has a similar dynamic behavior pattern as the original pier with almost constant shift in its acceleration response. The tied pier showed a different dynamic behavior than other repair techniques.

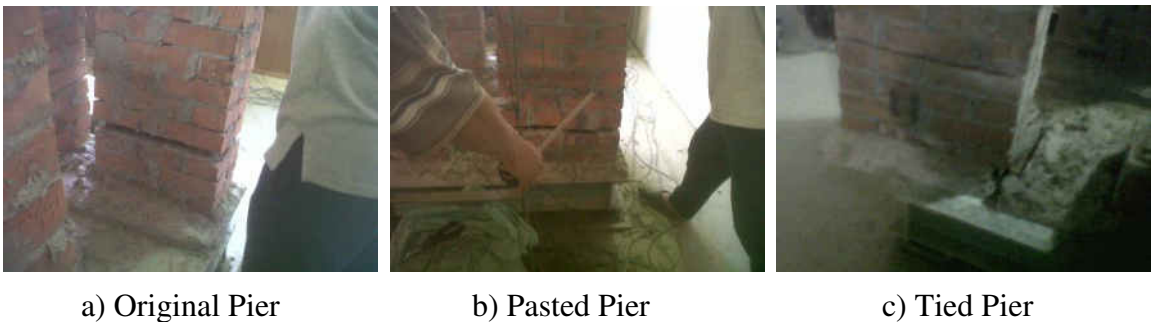
**Fig. 13.** Failure pattern for repaired piers.

The failure pattern for original pier, pasted pier and tied pier are showed in Figures (13-a), (13-b) and (13-c) respectively. The stapled pier was the last failed one. The pier failed also due to slipping failure but there are several cracks were formed on different location before slipping failure occurs. The formed cracks almost converted the pier into segments blocks connected by stapled bars. Figure 14 displays the formed cracks.

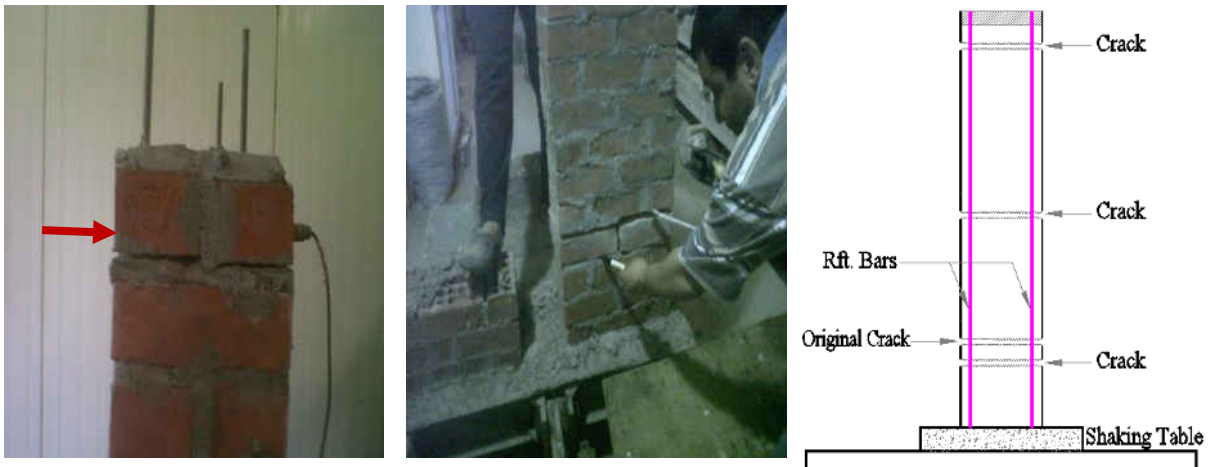
**Fig. 14.** Failure pattern for stapled piers.

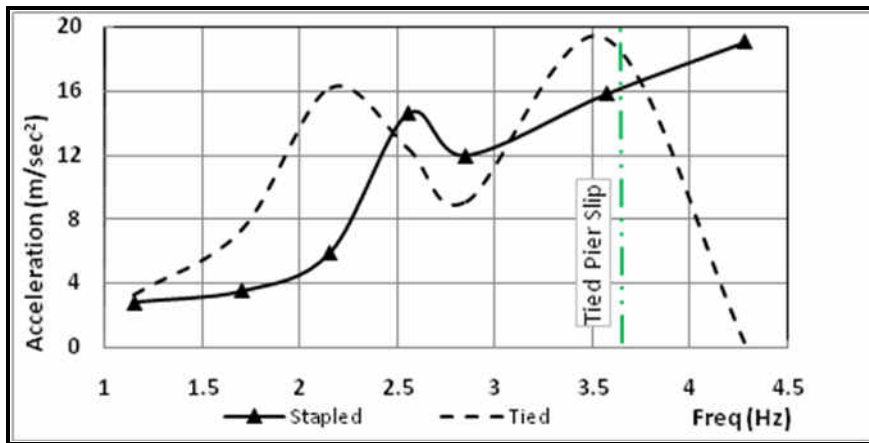
**Fig. 15.** Relation between peak acceleration response and frequency of input motion for tied and stapled pier.

The peak acceleration response under the effect ground motions with different frequencies was investigated. The applied ground motions varied from slight motions till motion causing pier failure. Figure 15 shows the relation between the peak acceleration response and the frequency of input motion applied on tied and stapled pier. It could be noticed from the plots that the stapled pier could stand against wider range of ground acceleration frequencies without failure than the tied technique. Also the dynamic behavior of the stapled technique showed lower acceleration responses than tied technique for most of the input ground motion.

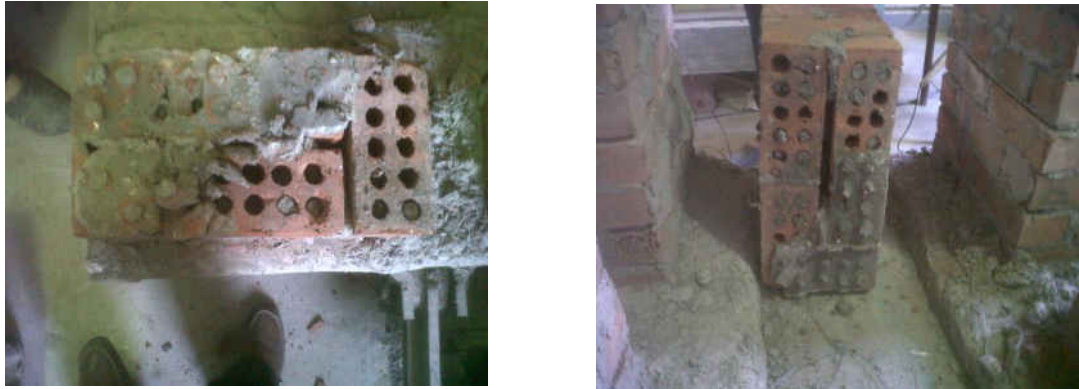
**Fig. 16.** Typical crack surfaces for failed piers.

The crack surface for all the piers were inspected to know the type of stresses causing failure. Fig. 16 shows the typical crack surfaces for failed piers. From the inspection processes, the major reasons of failure was due to debonding (bond failure) between mortar and bricks at the crack surface passing between the mortar layer and the bricks without causing any damages for either mortar or bricks. The mortar layer was almost

pulled out with keeping its shape that was previously formed after hardening during pier construction.
