STRENGTHENING OF R.C BEAMS WITH OPENINGS CREATED AFTER CASTING USING F.R.P

Mostafa Ahmed Mohamed and M. M. Ahmed

Civil Engineering Department, Faculty of Engineering, Assiut University, Assiut, Egypt.

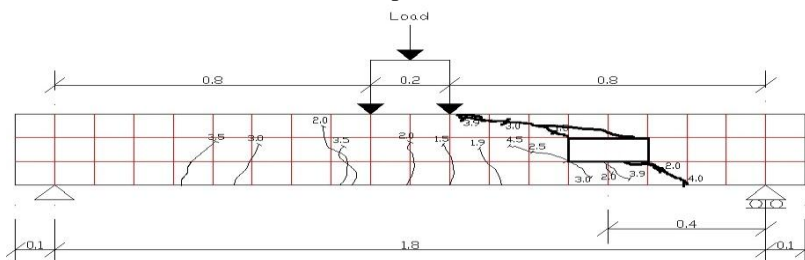
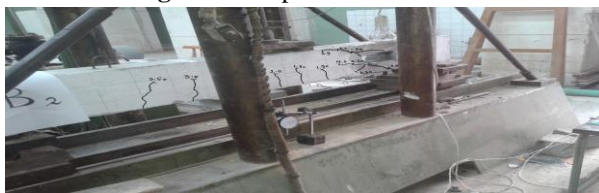
Fig. 6. Crack pattern of beam "B2".

The crack pattern for the beam “B2” with created unstrengthened openings and (h opening=8cm) is shown in Fig (6). The first crack was initiated at the mid span of beam at 1.5t, while the first shear crack was initiated at opening corner nearest to the support at a load of 2.0t. As the load increased, additional, new cracks were observed at the top and bottom chord of opening, and finally the beam failed at load of 4t by shear photo (5). In addition, the major cracks were located at the line joining the points of opening corner and either the nearest support or the point of load application.

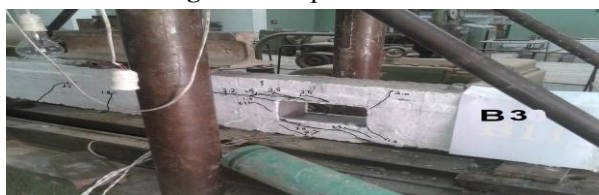
Fig. 7. Crack pattern of beam "B3".

Fig (7) and photo (6) show the pattern of cracks and modes of failure of beam “B3”. With created unstrengthened opening and (h opening=10cm), the first crack was initiated at the opening corner nearest to the support at a load of 1.5t, while first crack at the mid span of beam was initiated at 2.0t. As the load increased, new cracks were observed at the top and bottom chord of opening, the beam failed at load of 3.7t. The critical crack was formed at the line joining the points of opening corner and either the nearest support or the point of load application. The mode of failure, as indicated by photo (6) was a typical shear failure.

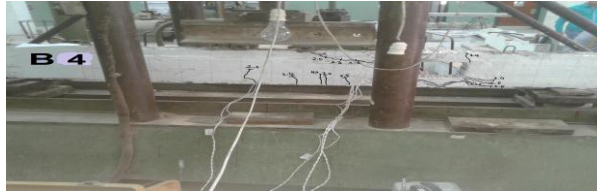
Fig. 8. Crack pattern of beam "B4".

The crack pattern for beam “B4” with created unstrengthened opening and (h opening=12cm) was shown in Fig (8). The first crack was initiated at opening corner nearest to the support at a load of 1.0t. While the first crack at the mid span of beam was initiated at 2.0t.

As the load increased, new cracks were observed in the top and bottom chord of opening. The beam failed by shear at opening zone at load of 3.5t. The major crack was located at the line joining the points of opening corner and either the nearest support or the point of load application. The mode of failure, as indicated by photo (7) was also a typical shear failure.

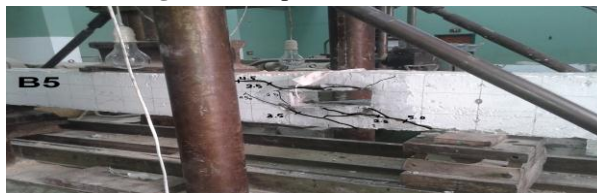
Fig. 9. Crack pattern of beam "B5".

For beam “B5” with created unstrengthened opening and ($a/d = 2.7$) the crack pattern is shown in Fig (9), The first crack at the mid span of beam was initiated at 1.5t, However first crack at the shear zone was initiated at opening corner nearest to the support at a load level of about 2.5t. As the load increased, additional, new cracks were observed at the top and bottom chord of opening, the beam failed by shear at load of 4.9t. In addition, the major cracks were located at the line joining the points of opening corners and either the nearest support or the point of load application. The mode of failure, as indicated by photo (8) was a typical shear failure.

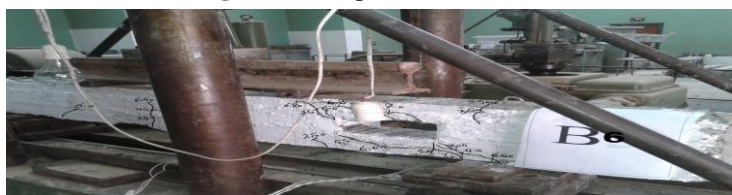
Fig. 10. Crack pattern of beam "B6".

For beam “B6” with created unstrengthened opening and ($a/d = 1.8$) was shown in Fig (10), the first crack was initiated at the mid span of beam at 2.5t , while the first crack at opening zone was initiated at the opening corner nearest to the support at a load of 3.5t. As the load increased, circumferential cracks were observed at the top and bottom chord of opening, the beam failed also by shear at load of 7.5t. The major cracks were located at the line joining the points of opening corner and either the nearest support or the point of load application. The mode of failure, as indicated by photo (9) was a typical shear failure.

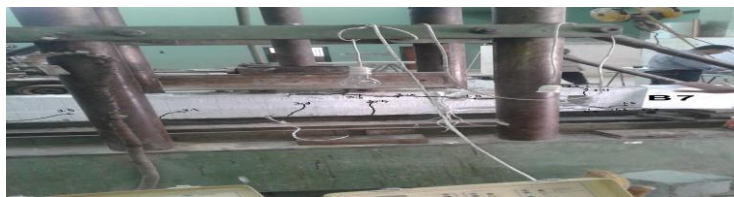
Fig. 11. Crack pattern of beam "B7".

The crack pattern for beam "B7" with created unstrengthened opening and ($f_{cu}=325\text{kg/cm}^2$) shown in Fig (11), the first crack was initiated at the opening corner nearest to the support at a load of 1.5t, and first crack was initiated at the mid span of beam at 2.0t. As the load increased, other cracks were observed in the top and bottom chord of opening, the beam failed by shear at load of 3.6t. A horizontal crack in the bottom chord was formed prior to failure owing to the absence of effective transverse reinforcement. The mode of failure, as indicated by photo (10) was a typical shear failure, along the line joining the load point and the support through the opening.

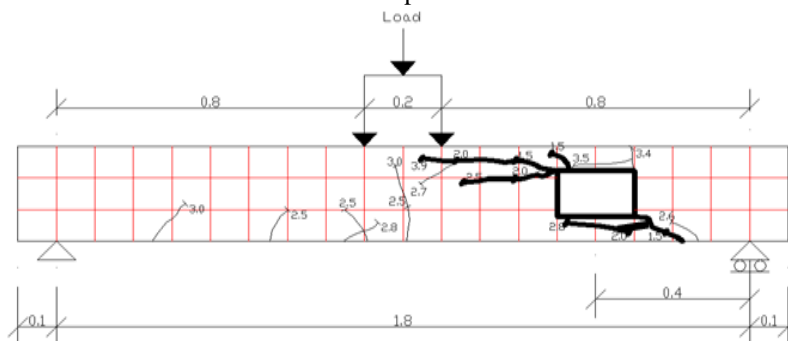
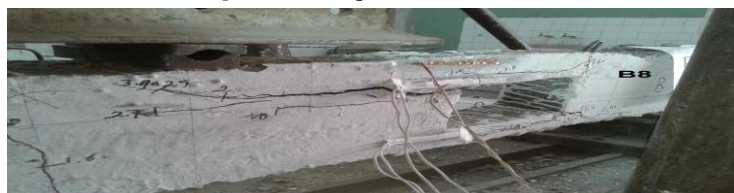
Fig. 12. Crack pattern of beam "B8".

The crack pattern for beam "B8" with created unstrengthened opening and ($f_{cu}=450$) was shown in Fig (12), the first crack was initiated at the opening corner nearest to the support at a load of 1.5t, and first crack at the mid span of beam was initiated at 2.10t. As the load increased, other cracks were observed at the top and bottom chord of opening, the beam failed at load of 4.2t. A horizontal crack was formed in the bottom and top chord of the opening. The mode of failure, as indicated by photo (11) was a typical shear failure.

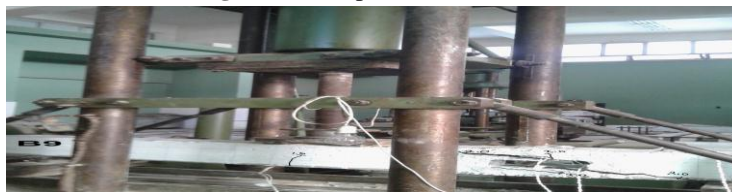
Fig. 13. Crack pattern of beam "B9".

The crack pattern for beam "B9" with created unstrengthened opening, is shown in Fig (13). The first crack was initiated vertically at the mid span of beam at 1.5t, while first crack at the opening corner nearest to the support was initiated at a load of 2.0t. As the load increased, new cracks were observed in the top and bottom chord of opening, the beam failed by shear at load of 2.4t. A horizontal crack was formed prior to failure. The mode of failure, as indicated by photo (12) was shear failure.

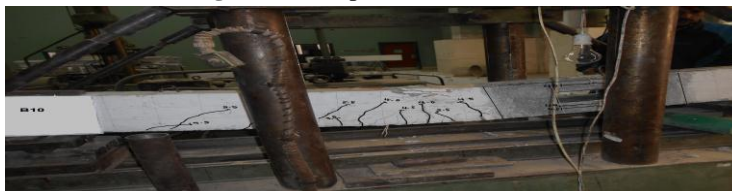
Fig. 14. Crack pattern of beam "B10".

Concerning the crack pattern for beam "B10" with opening strengthened by one layer CFRP. The first crack was initiated at the mid span of beam at, 2.5t. Fig (14). As the load increased, further flexural cracks were formed. Horizontal cracks were observed in the top and bottom chord of opening at a load of 4.5t, the beam failed at load of 5.5t. The major crack was vertical at mid span, accompanied by tearing of the CFRP layer in the top and bottom chord. The mode of failure is a typical shear-flexural failure. A sound like CFRP rupture it was heard prior to failure. See photo (13).

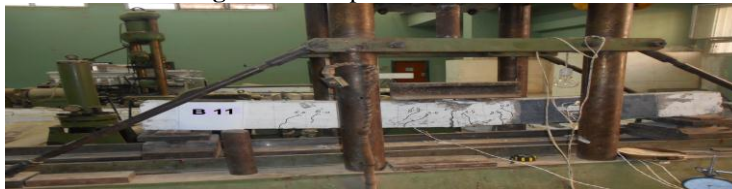
Fig. 15. Crack pattern of beam "B11".

The crack pattern for beam "B11" having a strengthened opening with two CFRP layers. No cracks were observed at the opening zone, and first crack was initiated at the mid span of beam at 2.5t.

As the load increased, other vertical cracks initiated and extended towards the points of load

application. The mode of failure, as indicated by photo (14) was a typical flexural one; the beam failed at load of 6.56t.

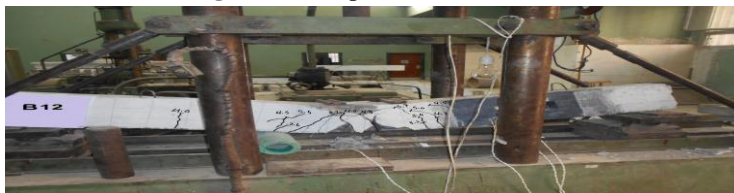
Fig. 16. Crack pattern of beam "B12".

In the beam “B12” having an opening with one cut stirrups and ($S^1=28\text{cm}$, $\rho_s=7.69 \times 10^{-5}$), strengthened with two layers from CFRP, is shown in Fig (16), the first crack was initiated at the mid span of beam at 2.6t. As the load increased, other flexural cracks initiated and extended towards the points of load application. Diagonal cracks were observed in the solid shear zones without opening at 4.5t. The mode of failure, as indicated by photo (15) was a typical flexural failure accompanied by crushing of concrete in the compression zone at load of 6.90t.

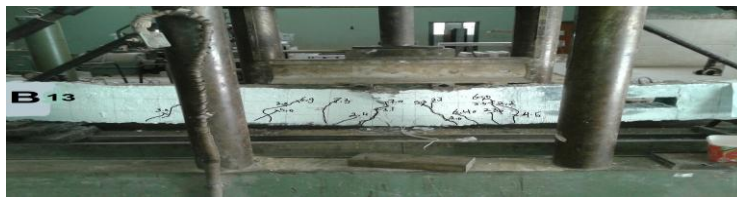
Fig. 17. Crack pattern of beam "B13".

For beam “B13” having an opening with two cut stirrups and ($\rho_s=4.49 \times 10^{-5}$), strengthened with two layers CFRP is shown Fig (17), the distance between unaffected stirrup in the opening zone= 48cm. No cracks was initiated at opening zone, and first crack was initiated at the mid of beam at 2.0t. As the load increased, other cracks initiated and extended towards the points of load application. Diagonal cracks were observed in the solid shear zones at 3.0t. Extended from a vertical crack, the mode of failure, as indicated by photo (16) was a typical flexural one. The beam failed at load of 6.0t.

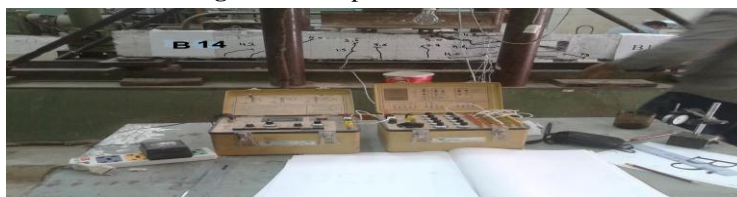
Fig. 18. Crack pattern of beam "B14".

The crack pattern for beam "B14" having a strengthened opening with two layers from CFRP and ($f_{cu}=250$), is shown Fig (18), the first crack was initiated at the mid span of beam at 1.5t.

As the load increased, other cracks initiated and extended towards the points of load application. The mode of failure, as indicated by photo (17), was a typical shear failure accompanied by sound like CFRP rupture. the strengthening layers were removed to see the cracks in the concrete beneath them. Diagonal and horizontal cracks were observed in the top and bottom chord of opening

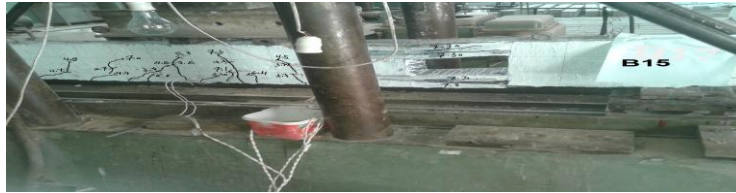
Fig. 19. Crack pattern of beam "B15".

However For beam "B15" having a strengthened the same strengthening scheme as in "B14" but with ($f_{cu}=325 \text{ kg/cm}^2$), the first crack was initiated at the mid span of beam at load level of about 2.0t. As the load increased, other cracks were initiated and extended towards the beam failed at load of 7.3t. The mode of failure, as indicated by photo (18) was a typical shear and flexural failure accompanied by sound like CFRP rupture. Horizontal cracks were observed after the removal of the strengthening layer in the top and bottom chord of the opening.

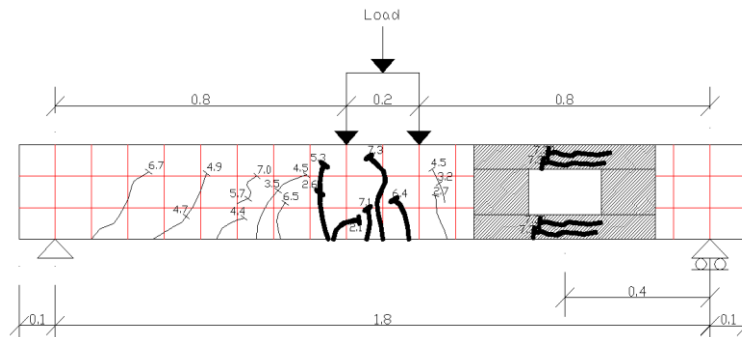
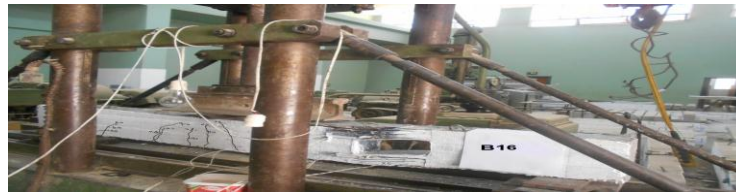
Fig. 20. Crack pattern of beam "B16".

The crack pattern for beam "B16" ($F_{cu}=450 \text{ kg/cm}^2$) is shown in Fig (20). The first crack at the mid span of beam was initiated at 2.50t. As the load increased, other cracks were observed at the top and bottom chord of opening, the beam failed at load of 7.90t. Prior to failure horizontal cracks were formed in the strengthening at top and bottom chord of opening. The mode of failure, as indicated by photo (19) was a typical shear and flexural failure accompanied by sound like CFRP rupture.

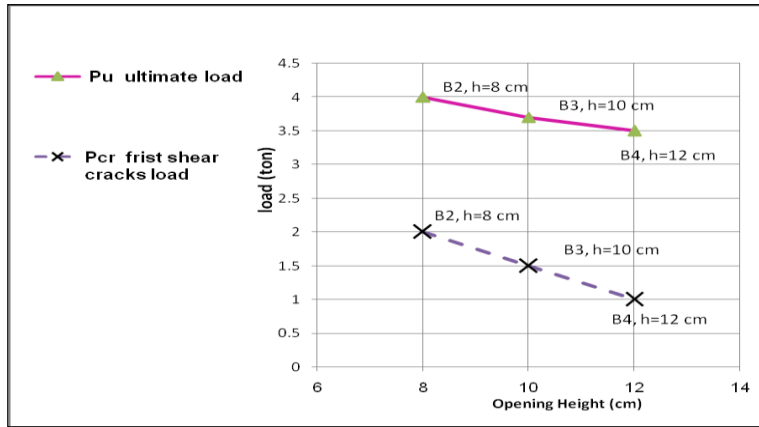
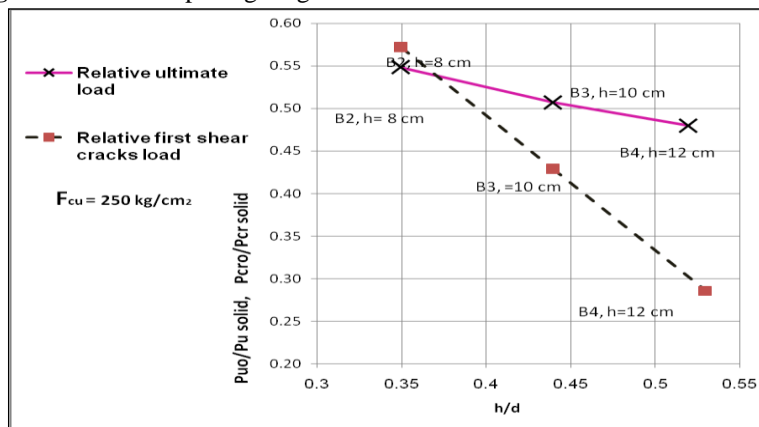
For beams "B2", "B3" and "B4" with variable unstrengthened opening height the first shear cracks was initiated in the opening zone at a load $2t$, $1.5t$ and $1t$ respectively. As the opening height increased the cracking and ultimate load decreased. In beam "B2" having an opening height of 8cm, the ultimate load was $4t$, while for beam "B3" which has an opening height of 10cm, the ultimate load was $3.7t$. Finally for beam "B4" with opening height of 12cm, the ultimate load was $3.5t$. The value of ultimate loads of beams "B2", "B3" and "B4" compared with those of the solid reference beam "B01" were 54.79%, 50.68% and 47.95% respectively, see Fig (21) and Fig (22).

Fig. 21. Effect the opening height on the ultimate load and first shear cracks load.

Fig. 22. Ultimate and first shear crack load relative to those of "B01" versus opening height ratio h/d

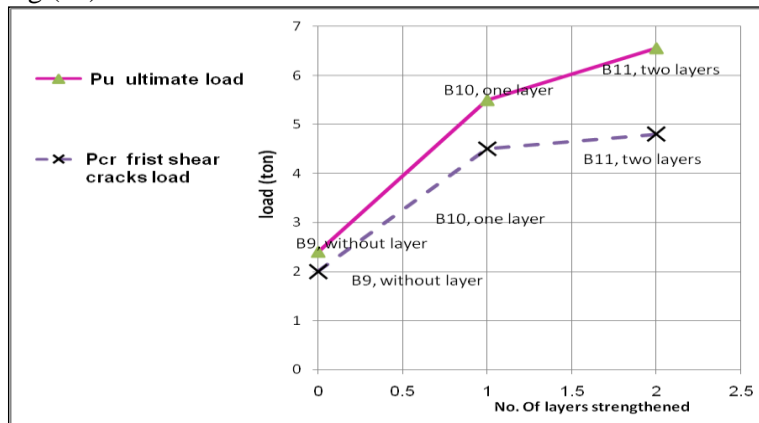
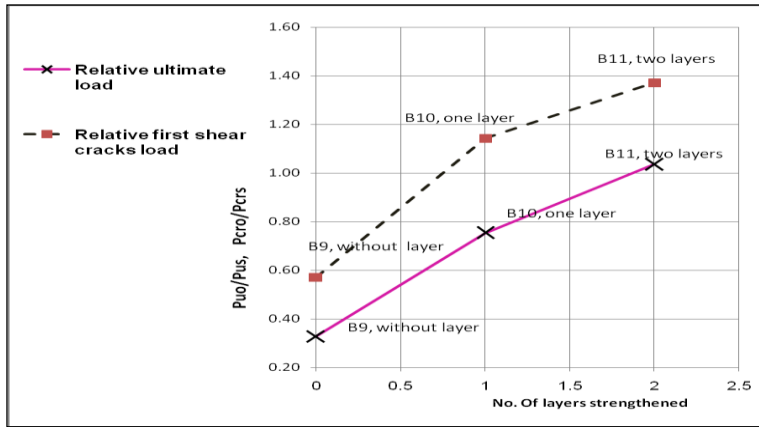
Also, strengthening the interior faces of the openings and around the openings on both sides of the beams by using one or two layers vertical and horizontal CFRP laminates increased the ultimate load; first shear cracks load and relative ultimate load as shown in Fig (23) and Fig (24).

Fig. 23. Effect of Number of Layers CFRP Strengthening on the ultimate load and first shear cracks load.

Fig. 24. Effect of Number of Layers CFRP Strengthening on the relative ultimate load and relative first shear cracks load

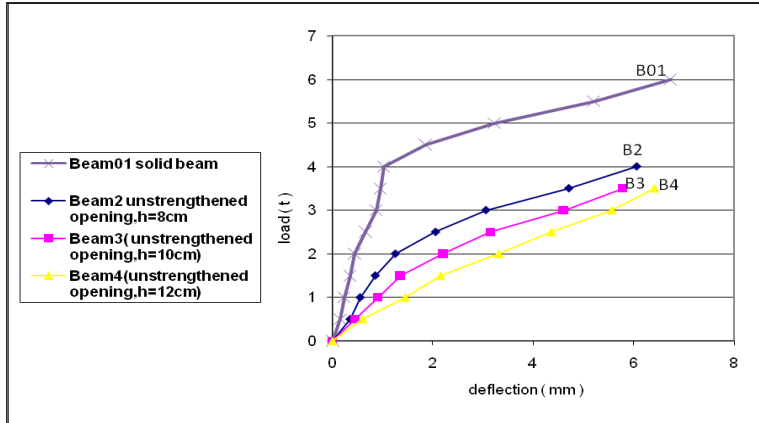
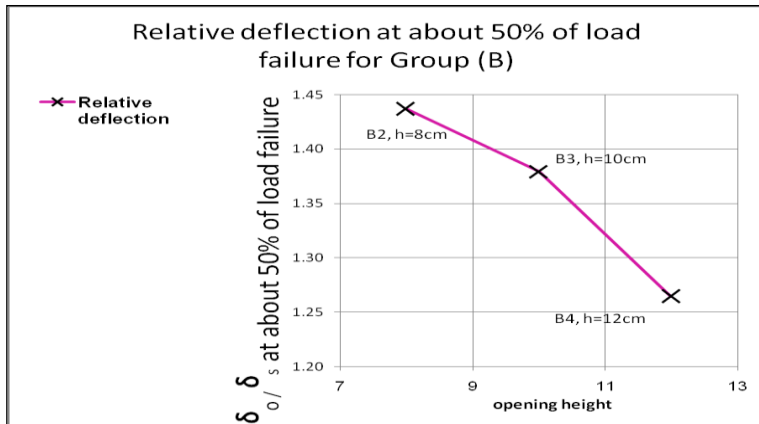
The measured values of mid span deflection at the bottom surface of the tested beams were plotted versus the corresponding applied load from zero loading up to failure, and are given in Fig (25) and Fig (26). As it was indicated in curves, the relation between the applied load and the corresponding deflection is approximately linear up to the cracking load. After cracking, deflection tends to deviate from linearity as the load increased, prior to failure, deflection increased rapidly and the curve became more flat.

The creation of openings had a noticeable effect on the mid span deflection. Deflection of the tested beams at any load level increased when providing an opening in their web compared with the solid beam Fig (25). In the same time as the opening height increased, the mid span deflection increased, the mid span deflection for beams B2, B3, B4 at about 50% of the failure load was 1.25, 2.20 and 3.31 mm respectively. See Fig (26).

Fig. 25. Load-Deflection curves for beams "B2", "B3" and "B4" and "B01"

Fig. 26. Relative deflection for beams "B2", "B3" and "B4"

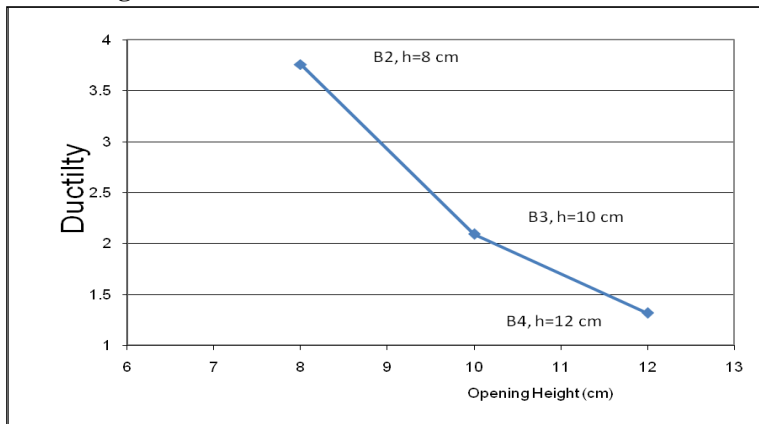
Ductility factor is measured using various methods. it can be defined as the ratio of the ultimate deformation (curvature or deflection) to the deformation at first yield (or at the working stage). An accurate value of the ultimate deflection can be considered to that at 90% of failure load. The deflection at working load may be assumed to be that corresponding to about 50% of failure load. The ductility factor here was measured using the ratio of the deflection at load corresponding to about 90% of the failure load to that corresponding to about 50% of failure load. The ductility factor decreased as the opening height increased. Fig (27).

Fig. 27. Effect the opening height on Ductility

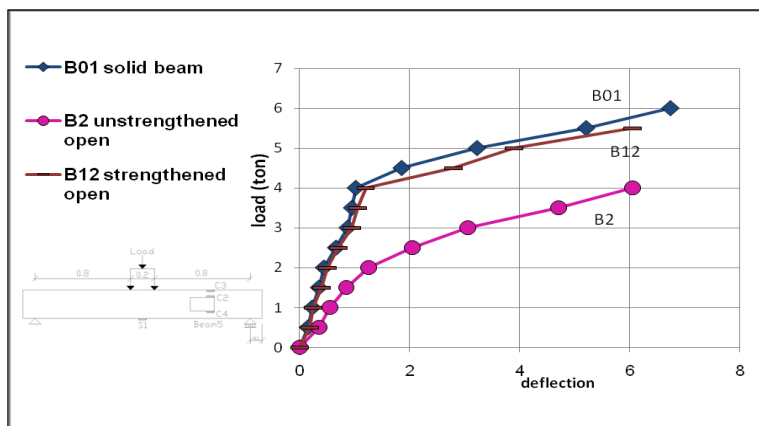
Strengthening of the opening zone noticeably reduced the mid span deflection, Fig (28). Mid span deflection for beam B12 strengthened with two layers at the opening zone was slightly smaller than that of the solid reference beam B01. This may attributed to the following reasons:

- CFRP sheets around openings help in resisting stress concentration at opening corners and compensate the cut web reinforcement thus delaying cracking and controlling cracks propagation, which as a result increase the stiffness of the beam.
- The virtual area of CFRP sheets, which confining concrete section above and below opening helps to strengthen those sections to act as one which improves stiffness of beam.

Fig. 28. Load-Deflection curves for "B01", "B2" and "B12"
