RETROFITTING AND STRENGTHENING OF REINFORCED CONCRETE COLUMNS USING STEEL JACKETS; MECHANICAL PERFORMANCE AND APPLICATIONS

Ahmed El-Badawy Sayed,

Assoc. Prof. Civil Eng. Dept., Minia University Minia 6111, Egypt.

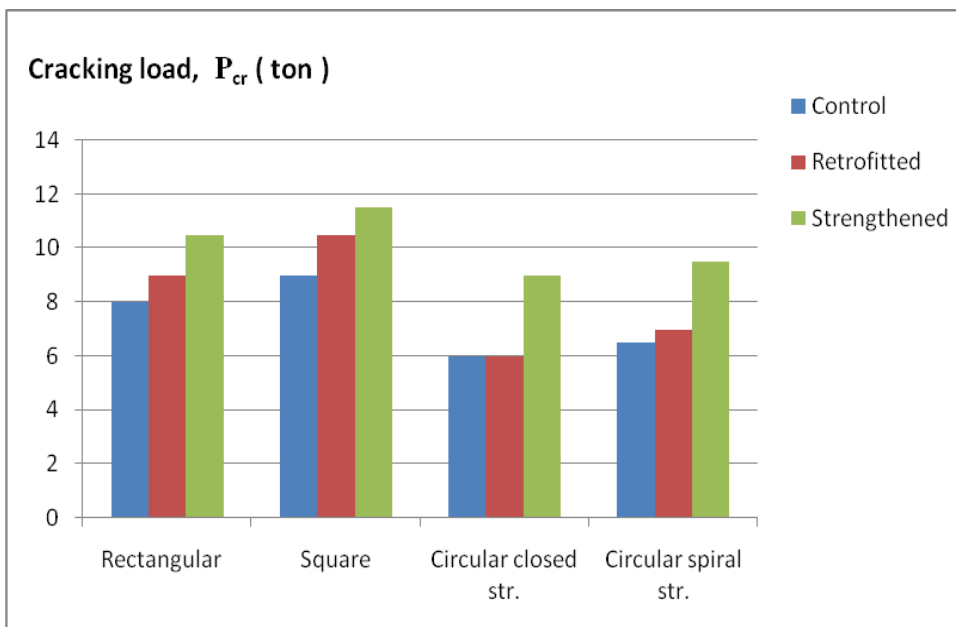
Figure (4) Comparison between cracking loads of the tested columns.

The experimental values of cracking and ultimate loads obtained from testing the twenty four specimens of the three groups of columns are recorded in table (1) and illustrated in figures (4&5). Table (1) also contains the ratios between the cracking and ultimate loads (P_{cr} / P_{ult}) for each column individually. It can be resulted that, the lowest ratios of (P_{cr} / P_{ult}) were recorded with rectangular columns regardless of being them retrofitted or strengthened. The average value of these ratios was found to be 0.35 compared with 0.47 and 0.53 for square and circular columns respectively.

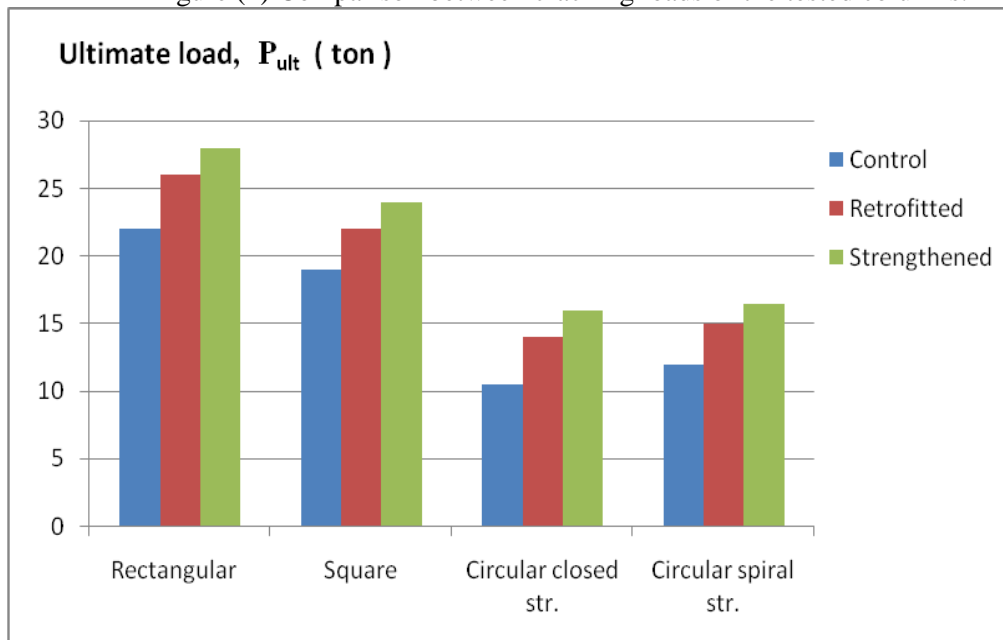
Figure (5) Comparison between ultimate loads of all tested columns.

Generally, the highest values of ultimate loads were resulted from testing the rectangular columns. These values were found to be as twice as those obtained from the two types of circular ones. This result is true for the three groups of the tested columns – see table (1) and figure (5).

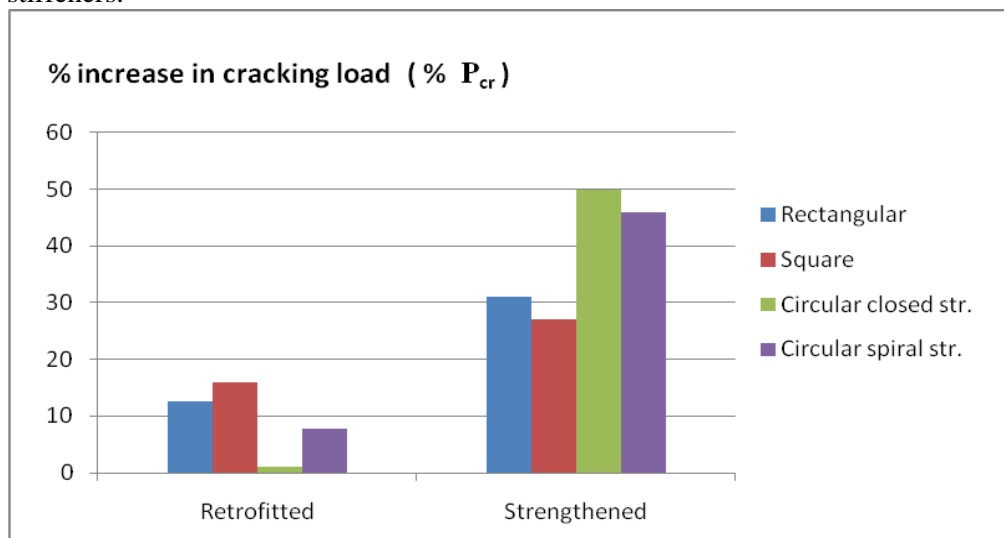
Figure (6) % Increase in the cracking loads of retrofitted and strengthened columns as a result of applying the steel jackets.

Figures (6&7) illustrate the beneficial effect of steel jacketing technique, adopted in this research, in form of % increase in the cracking and ultimate loads for the different cross-sections used with retrofitted and strengthened columns.

Figure (6) explains how the cracking loads of retrofitted and strengthened columns have been improved when compared with the control ones. About 10 % increase in the cracking loads have been achieved as a result of retrofitting cracked columns by applying steel jackets around them. However, strengthening original columns produced about 30 % increase in cracking loads of rectangular and square columns whereas, circular columns produced about 50 % improvement.

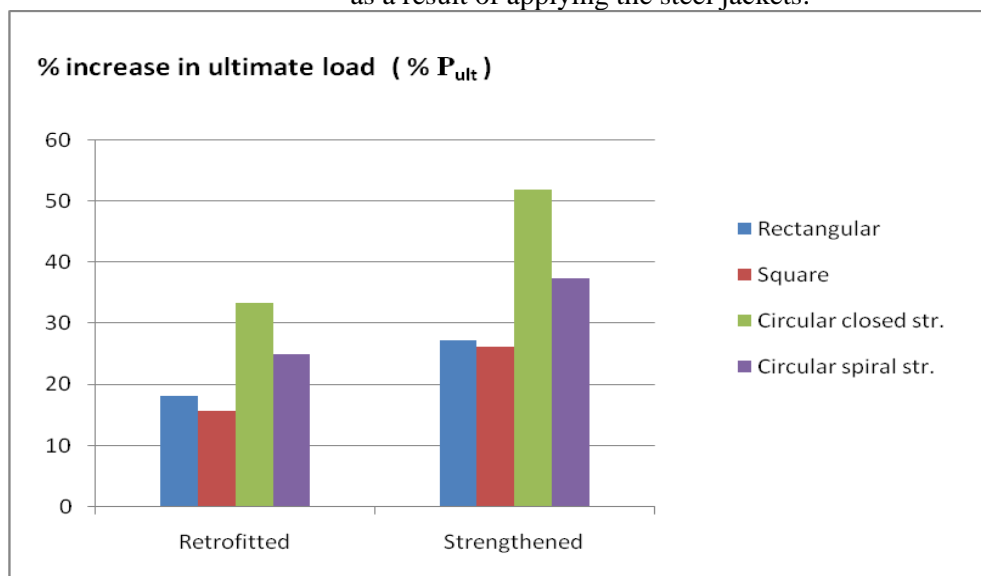
Figure (7) % Increase in the ultimate loads of retrofitted and strengthened columns as a result of applying the steel jackets.

The significant increase in the load bearing capacity of the retrofitted and strengthened columns when compared with the values of ultimate loads obtained from the control ones is represented in figure (7). An improvement of about 20 and 30 % has been recorded with retrofitted and strengthened respectively. This tremendous achievement could be attributed to the effect of increasing the percentage of reinforcements (μ %) resulted from applying the additional reinforcement of the steel jacket, (μ % increased from 2% to 4% in rectangular and square columns meanwhile, increased to 2.3% in circular columns) as well as to the effect of the extra confinement produced from the welded tied plates used with the steel jacket which works as stiffeners.

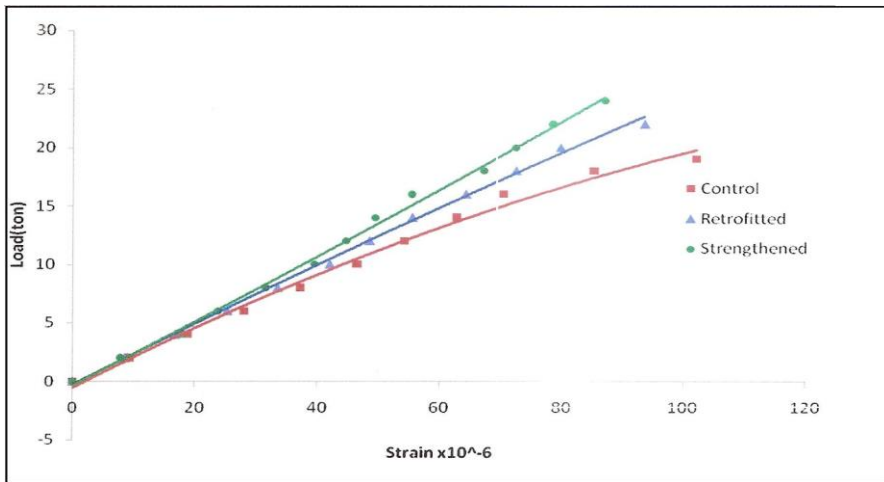
Figure (9) Load – strain relationship for square columns.

Figures (8, 9, 10 and 11) plot the load – concrete strain relationships for the three different groups of columns. Figures (8) and (9) consider the rectangular and square columns meanwhile; figures (10) and (11) illustrate the circular columns with loop and spiral stirrups respectively. The concrete strain was measured using extensometer through the demic points (studs) stuck on two opposite sides of the columns at the middle third. It can be observed that, same trends were obtained from testing the three categories of columns except for slight differences in the strain values were noticed.

From these figures it can be observed that, at a constant load, strengthened columns showed lower strain values than the retrofitted ones meanwhile, the values of strains accompanied with the original control columns were less than both. Therefore it can be concluded that, steel jacketing technique increases the stiffness of the reinforced concrete columns.

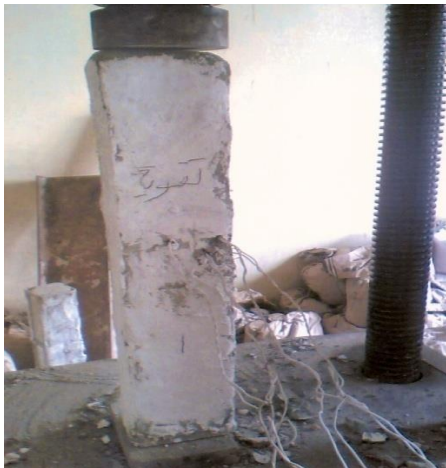
Figure (12) Testing one of the strengthened column.

Figures (12 - 17) show the damaged reinforced concrete retrofitted and strengthened columns at the end of the tests. The Steel jacketed rectangular and square columns first experienced vertical cracks in the concrete cover followed by cover spalling and eventually a buckling in the longitudinal bars occurred. However, the steel jacketed circular columns exhibited also vertical cracks and spalling of the new concrete cover followed by a local buckling around the mid-height of the columns, which eventually led to buckling at very large axial displacements followed by a fracture in the vertical reinforcement of the jacket around the column. In general, it could be strongly conclude that, the strength and stiffness of columns are greatly improved as a result of applying the steel jackets.

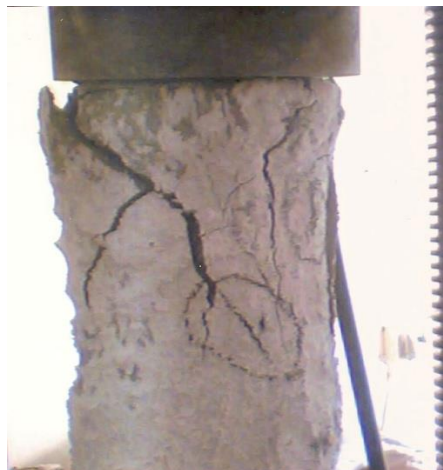
Figure (13) Cracking of circular column and the .The cover stated to spall out.

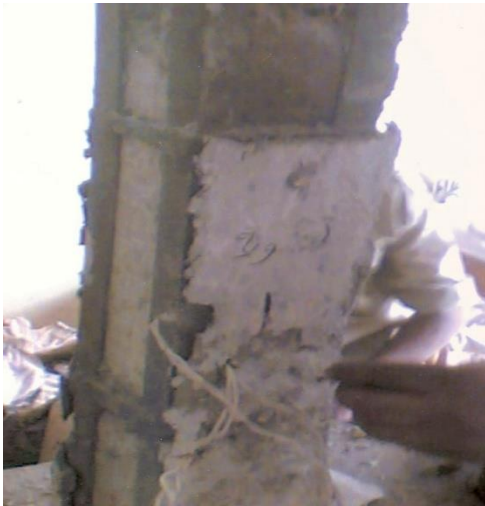
Figure (14) Spalling of the concrete cover of rectangular column.

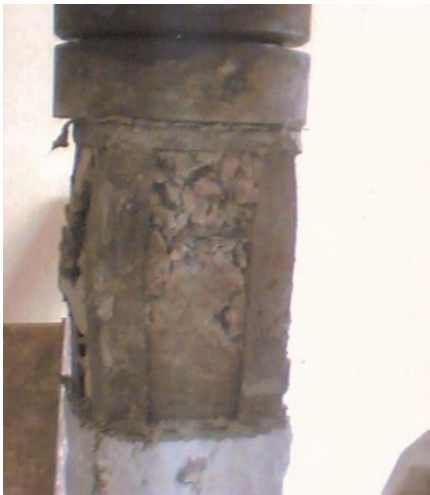
Figure (15) Spalling of the concrete cover of circular column.

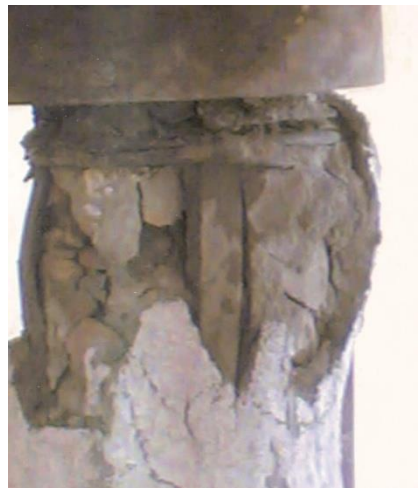
Figure (16) Buckling of the vertical steel plates of the circular column.

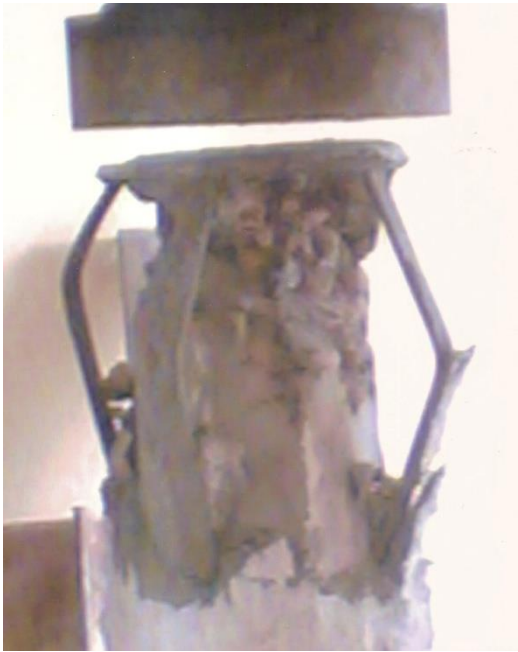
Figure (17) total fracture of the column and the steel jacket of the circular column.

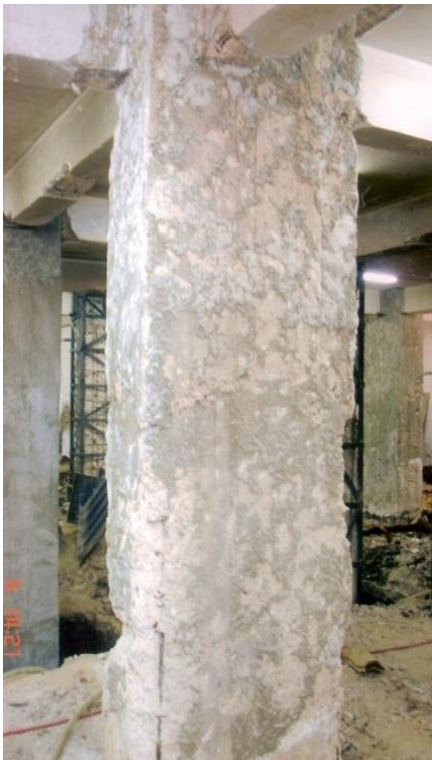
Plate (1) Deteriorated column before applying the steel jacket.

This proposed retrofitting technique has been successfully applied in several construction projects since 1999 particularly; to retrofit the deteriorated reinforced concrete columns damaged by the occurrence of rebar corrosion. The cases studied in this part of the research are, the following projects;

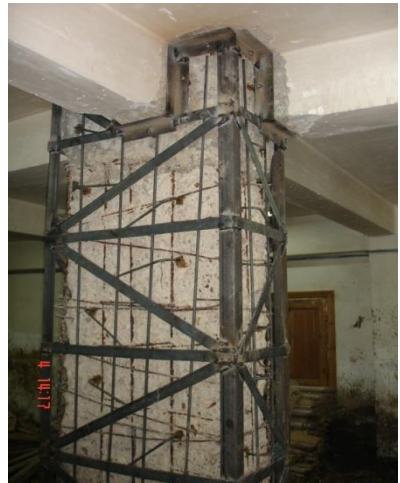
Plate (2) The steel angles and both the transverse and diagonal plates of the jacket.

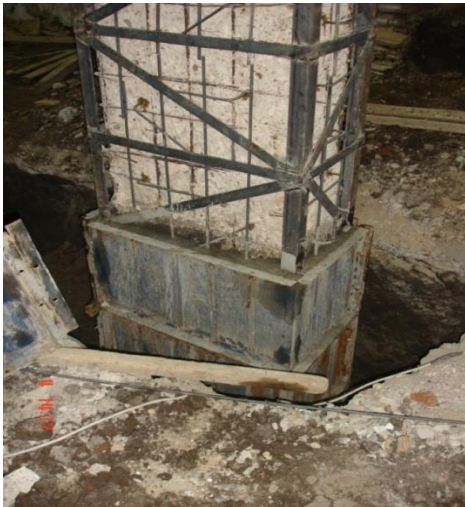
Plate (3) Casting of the new concrete cover starting from above the footing.

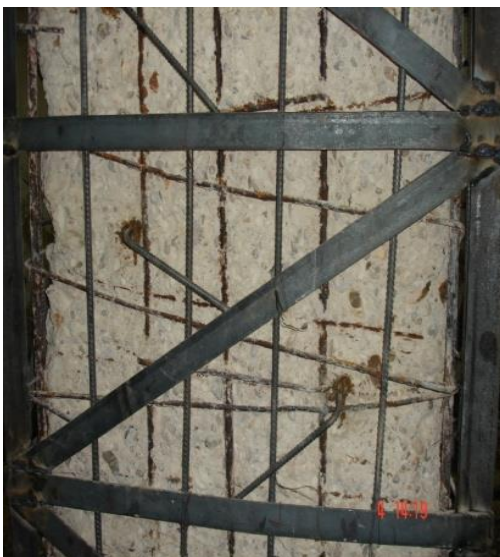
Plate (4) Focused view for the components of the used steel jacket.

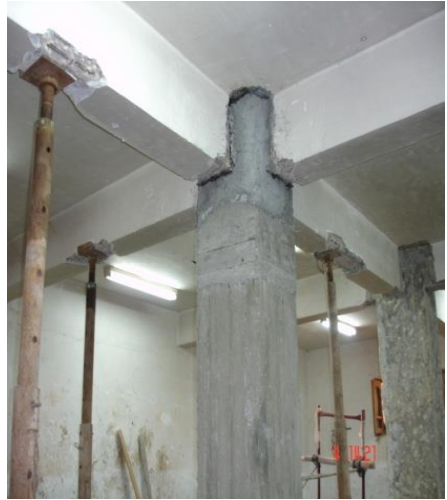
Plate (5) The concrete cover of the connection between the column and the beam.

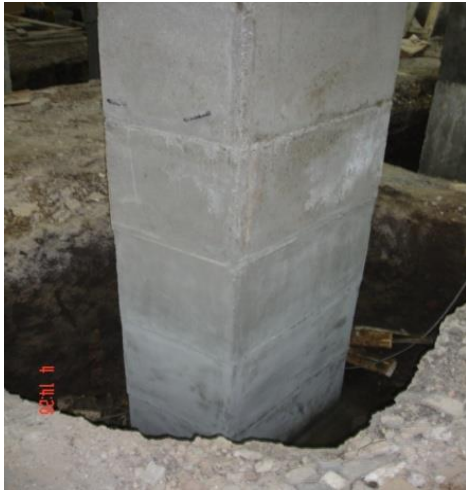
Plate (6) The concrete cover has been finished after the execution of steel jacket.
