Documenting and Analyzing the Harmful Impacts of The Seasonal Floods in Upper Egypt on Qena-Safaga Railway Track Infrastructure

Torrents and Flash floods
– Railway Infrastructure -
Railway Track Drainage

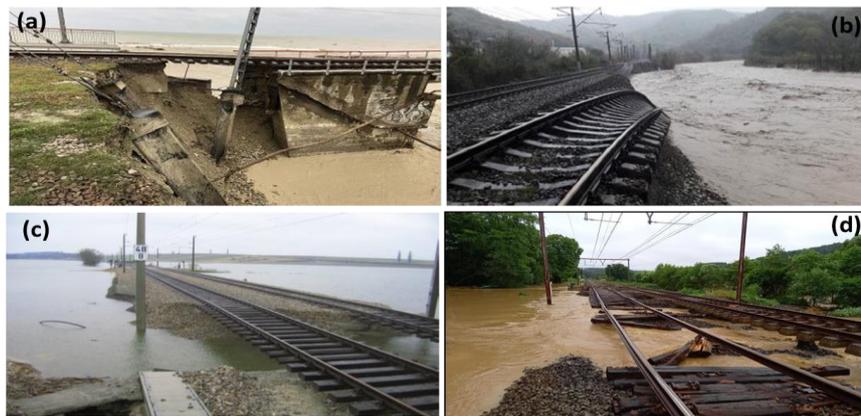
Figure 6 Some cases of flood damage, (a) Railway bridge scour; (b) Railway infrastructure damage in Russia [6]; (c) Rail damage in Austria [2]; and (d) Rail damage in Belgium [7].

It is clear from Table 3 as well as Figure 5 that the most harmful effects were on the standard cross-section (substructure, superstructure, and contact line) (13 cases). The remaining cases varied between destroying a railway bridge (8 cases) and the accumulation of debris and mud on the track and stations (3 cases). Also, there were many cases of damage to signal boxes and rail equipment. This is due to failure of other elements, such as failure of bridges, signals, and railway equipment, which is mainly associated with (SCS) failure, as shown in Figure 6.

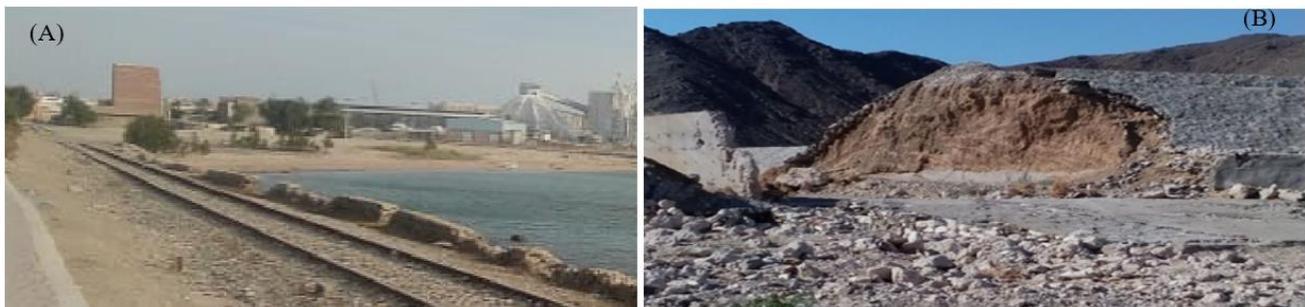
The table shows that some of the implemented treatments are effective to some extent, while others are not, particularly with high-energy floods, as shown in figure 20. As shown in Figures 21 and 22, the table also includes some treatments for other cases as a suitable alternative to the treatments implemented for the track under study.

Figure 20 Examples of ineffective implemented treatment methods: (A) Failure of Stone-built barriers, (B) Embankment failure.
